ARB6 - Re-Programming High-Voltage Battery Control Unit (BMCe) (Recall Campaign)

Action:	<ul style="list-style-type: none"> Determining the period since the last check of the high-voltage battery Re-programming the high-voltage battery control unit (BMCe) with the latest PIWIS Tester software release Minimum requirement: Release 43.500.000

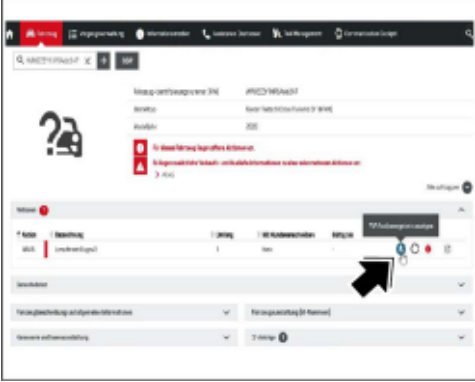
<p>Pop-up display window</p>
<p>- Green display: The test result is "positive". Cell modules are OK, carry out the programming of the high-voltage battery control unit.</p>

<p>3. VAL analysis result is displayed via pop-up window</p>

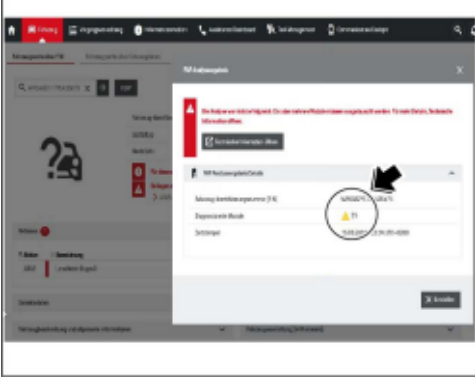
<p>"Red" display result</p>

<p>"Green" display result</p>
<p>- Red display: The test result is "negative". One or more modules must be replaced after the control unit programming.</p>

- The data analysis yields a **negative result** (red PCSS display): **First re-program the high-voltage battery control unit (BMCe)** ⇒ *Technical Information '9X00IN Automatically re-programming the high-voltage battery control unit (BMCe)'*. **Thereafter**, repair the high-voltage battery according to the additionally assigned **campaign ARB5**.

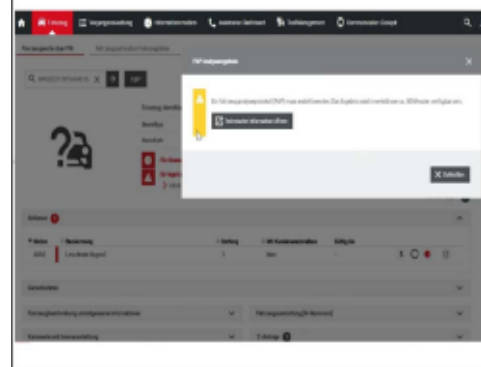
"Yellow" display result

- **Yellow display:** The vehicle analysis log (VAL) cannot be evaluated, but the high-voltage battery control unit is still to be programmed.

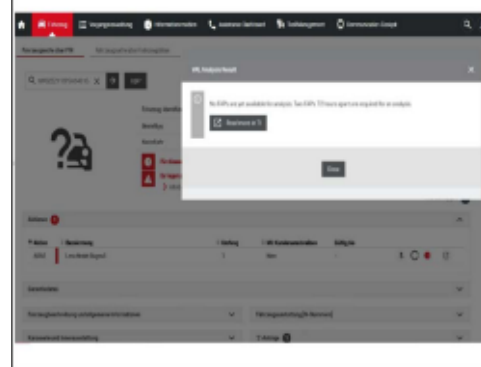
"Grey" display result

- **Grey display:** The vehicle analysis log (VAL) cannot be evaluated, but the high-voltage battery control unit is still to be programmed.
