**Complaint - Cylinder Head Cover Near the Injector Holes Leaking: Subsequent Work on Cylinder Head (180/18)**

Vehicle Type: **Panamera (971/YAA)/Panamera 4 (971/YAA)/Panamera 4S (971/YAA)/Panamera 4 E-Hybrid (971/YAA)/Panamera 4S E-Hybrid (971/YAA)**

Concerns: **Cylinder head cover**

Cause: **Complaint about injector hole leaks**

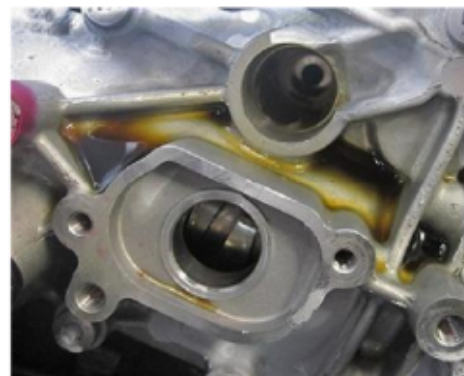
2.3.1 Oil must have collected in the vicinity of the injector of the affected cylinder and the insulation on the bottom of the cylinder head cover should be fully soaked.

*Fault type 2: Cylinder head cover leaking*

2.4 To remove cylinder head cover and dispose of old seal, see ⇒ *Workshop Manual '158219 Removing and installing cylinder head cover (V6 turbo)*.

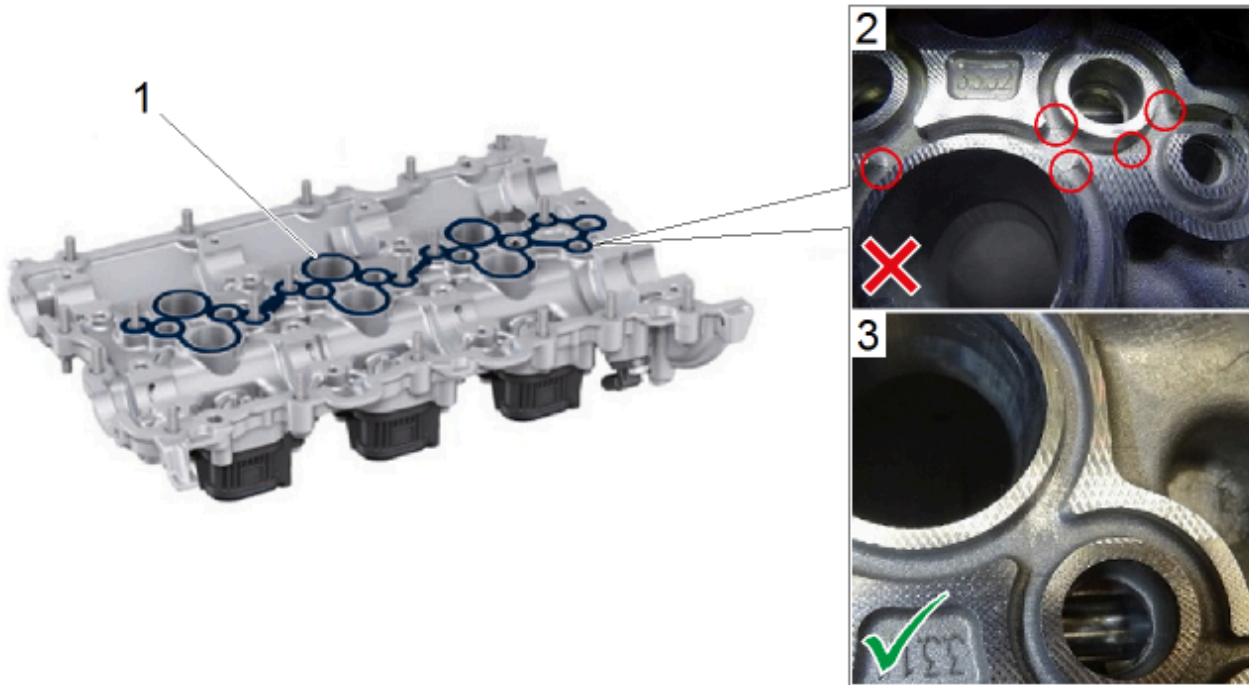
- Due to a batch error in the casting procedure there may be cast residue in the cylinder head cover sealing groove.
- This cast residue may cause the injector holes to leak.

2.6 Check the sealing groove (⇒ *Cylinder head cover sealing groove -1-*) of the cylinder head cover visually. Be particularly meticulous when doing this especially in the vicinity of the affected cylinder.

*Cylinder head cover sealing groove*

2.7 Carefully remove any cast residue (⇒ *Cylinder head cover sealing groove -2-*) using a **small flat screwdriver, ensuring that the sealing groove is not damaged**. There must be no more cast residue in the sealing groove after machining (⇒ *Cylinder head cover sealing groove -3-*).
