Complaint - Cylinder Head Cover Near the Injector Holes Leaking: Subsequent Work on Cylinder Head (180/18)

Vehicle Type: **Cayenne (9YA/9YB)/Cayenne E-Hybrid (9YA/9YB)/Cayenne S (9YA/9YB)/Cayenne S E-Hybrid (9YA/9YB)**

Concerns: **Cylinder head cover**

Cause: **Complaint about injector hole leaks**

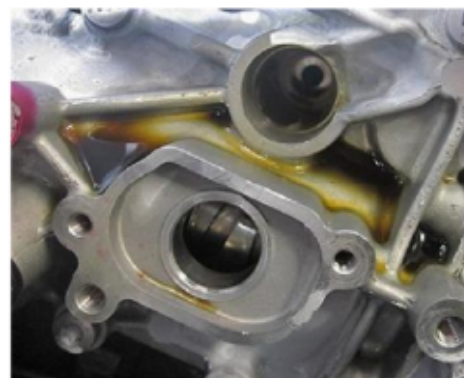
2.3.1 Oil must have collected in the vicinity of the injector of the affected cylinder and the insulation on the bottom of the cylinder head cover should be fully soaked.

Fault type 2: Cylinder head cover leaking

2.4 To remove cylinder head cover and dispose of old seal, see ⇒ *Workshop Manual '158219 Removing and installing cylinder head cover (V6 turbo)'*.

Create informative photo documentation of the damaged seal and attach it to the process in PCSS.

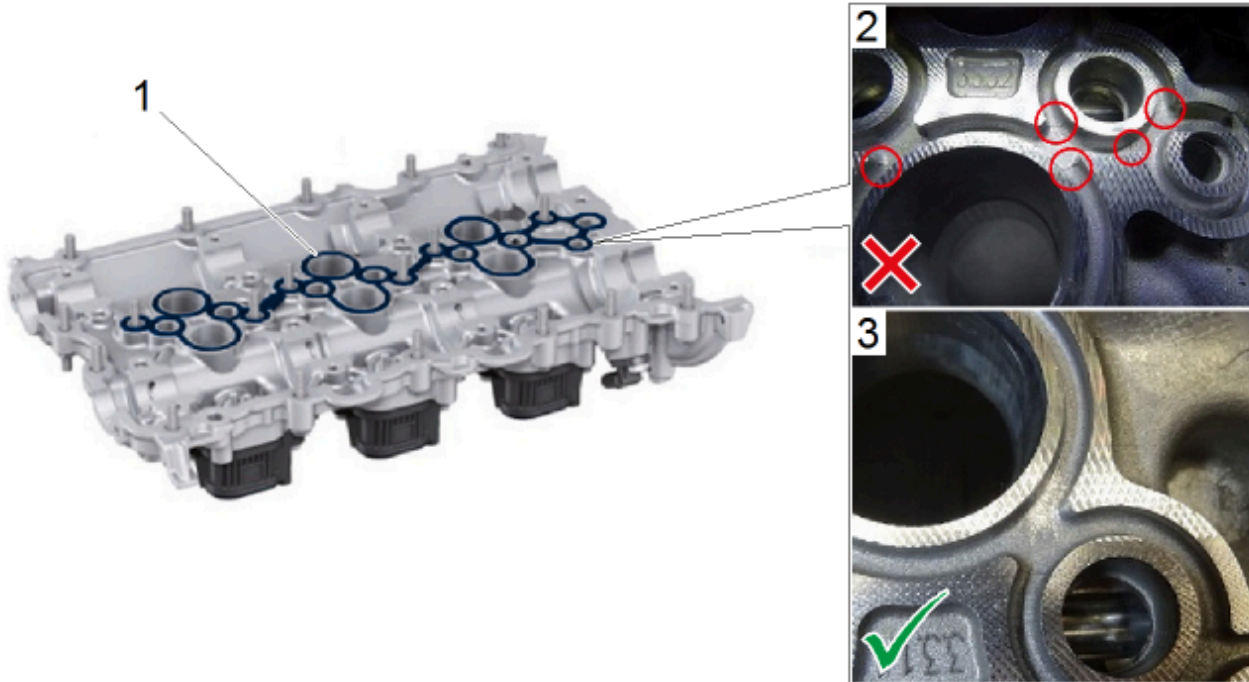
- Due to a batch error in the casting procedure there may be cast residue in the cylinder head cover sealing groove.
- This cast residue may be the reason for leaks in the injector holes.

2.6 Check the sealing groove (⇒ *Cylinder head cover sealing groove -1-*) of the cylinder head cover visually. Be particularly meticulous when doing this especially in the vicinity of the affected cylinder.

Cylinder head cover sealing groove

2.7 Carefully remove any cast residue (⇒ *Cylinder head cover sealing groove -2-*) using a small flat screwdriver, ensuring that the sealing groove is not damaged. There must be no more cast residue in the sealing groove after machining (⇒ *Cylinder head cover sealing groove -3-*).
