Complaint - Cylinder Head Cover Near the Injector Holes Leaking: Subsequent Work on Cylinder Head (180/18)

Vehicle Type: **Macan S (95B) / Macan GTS (95B) / Macan Turbo (95B)**

Concerns: **Cylinder head cover**

Cause: **Complaint about injector hole leaks**

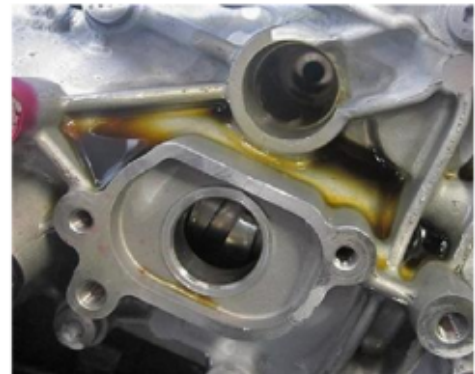
Fault type 2: Cylinder head cover leaking

- Due to a batch error in the casting procedure there may be cast residue in the cylinder head cover sealing groove.
- This cast residue may be the reason for leaks in the injector holes.

2.3.1 Oil must have collected in the vicinity of the injector of the affected cylinder and the insulation on the bottom of the cylinder head cover should be fully soaked.

2.4 To remove cylinder head cover and dispose of old seal, see ⇒ *Workshop Manual '158219 Removing and installing cylinder head cover (V6 turbo)'*.

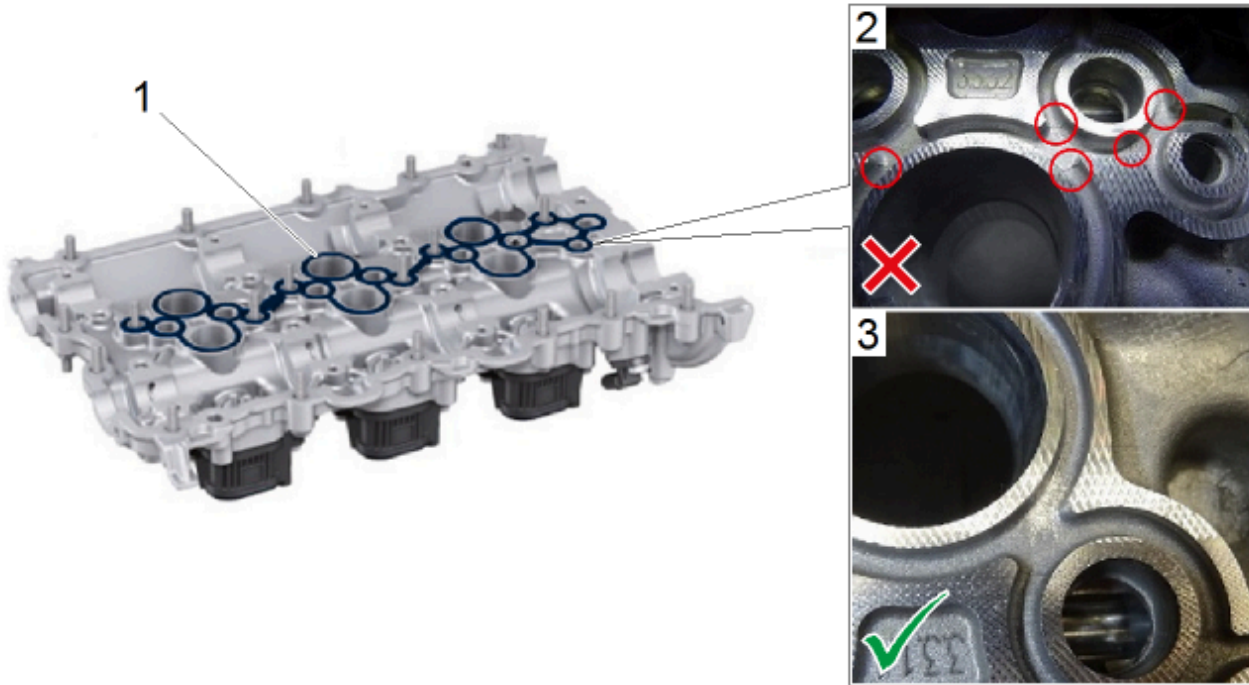
Cylinder head cover sealing groove

2.6 Check the sealing groove (⇒ *Cylinder head cover sealing groove -1-*) of the cylinder head cover visually. Be particularly meticulous when doing this especially in the vicinity of the affected cylinder.

2.7 Carefully remove any cast residue (⇒ *Cylinder head cover sealing groove -2-*) using a small flat screwdriver, ensuring that the sealing groove is not damaged. There must be no more cast residue in the sealing groove after machining (⇒ *Cylinder head cover sealing groove -3-*).
