Volvo Car USA LLC

Technical Journal

Technical Journal Title CEL with DTC ECM P001100, P001200, P001400, P001500		Ref. No. TJ 37148.4.0	
Issuer (Dept.) Technical Service		Issue Date 4/23/25	Status Date 4/30/25
Car Market United States and Canada	Partner 3 US 7510 Volvo Car USA	Function Group 2154	
Function Description Camshaft		Page Page 1 of 4

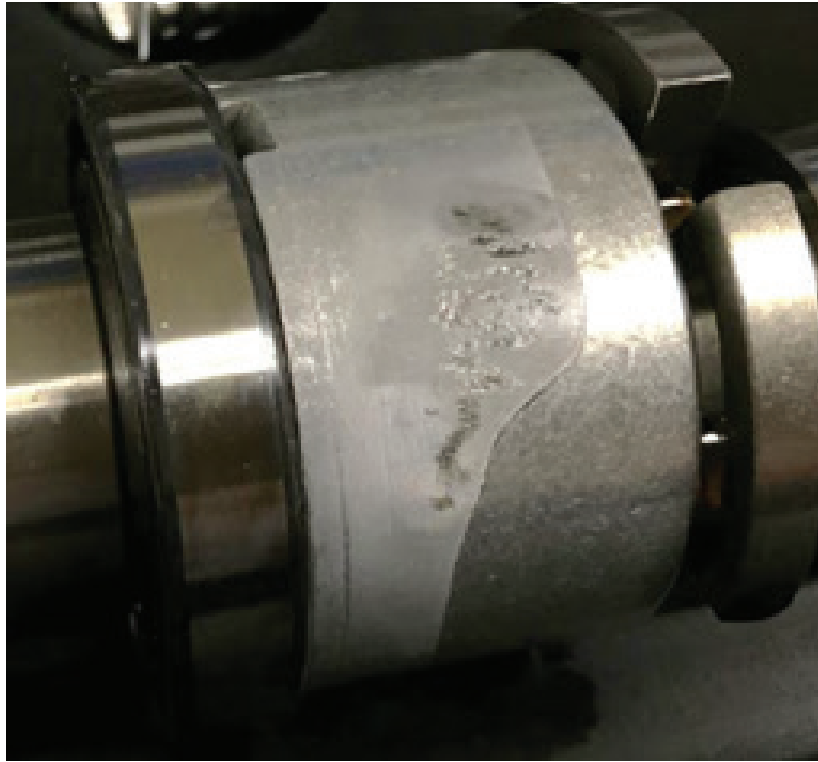
*Wear on the outside of the camshaft is not a reason to replace the part. Compare with the attached file TJ_36920_1.PNG.
