Technical Journal

Technical Journal Title Charging Limited to 10A, EVI Release Wire Stuck		Ref. No. TJ 37304.1.0	
Issuer (Dept.) Technical Service		Issue Date 5/9/25	Status Date 5/15/25
Car Market United States and Canada	Partner 3 US 7510 Volvo Car USA	Function Group 3771	
Function Description Cable harness, central high voltage cable		Page Page 1 of 3

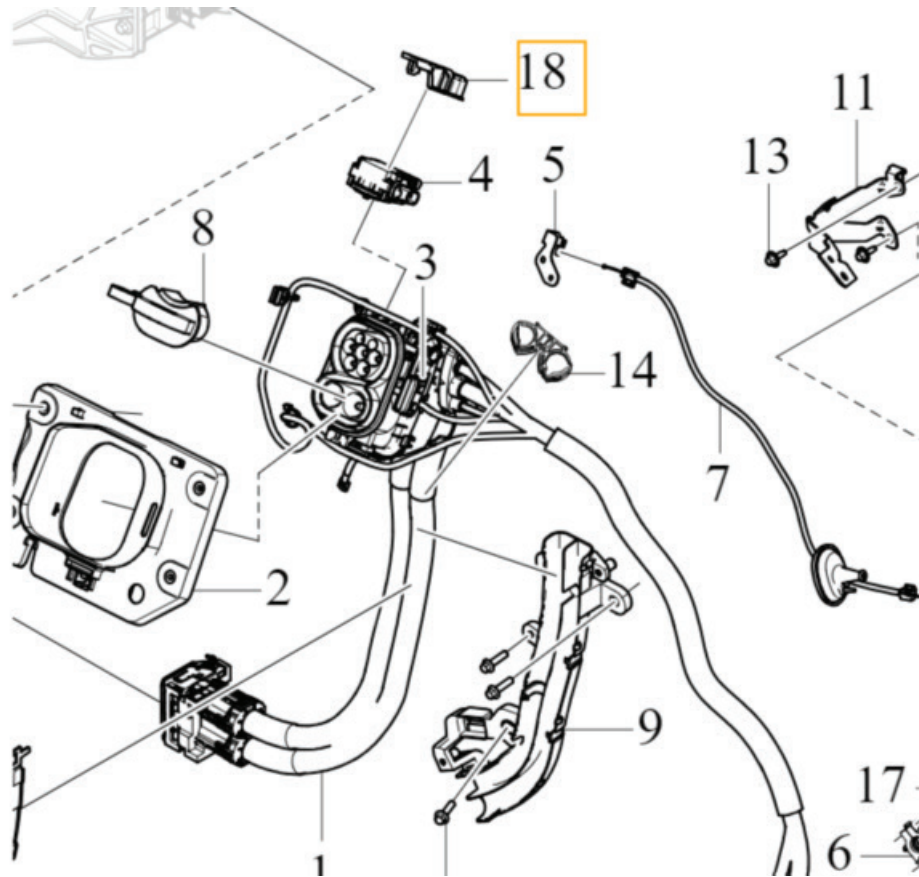
File Name	File Size
Parts Image.png	0.1811 MB

If a customer experiences AC charging limited to 10 Amps and DC charging not working, the root cause may be the EVI release wire not retracting. Please follow the advice under "Service".

In cases where the EVI locking actuator/motor is unable to retract the release wire from the released position (wire pulled out in the trunk) back to the standby position, replace the actuator cover (part #18 in the attachment "Parts Image").

Follow the VIDA instructions for removal, replacement, and installation of the "Charge connector locking motor."
