| Technical Journal Title Park Assistance System enhanced troubleshooting | | Ref. No. TJ 36965.2.0 | |
| Car Market United States and Canada | Partner 3 US 7510 Volvo Car USA | Function Group 3871 | |
| Function Description Parking assistance | | Page Page 1 of 3 | |

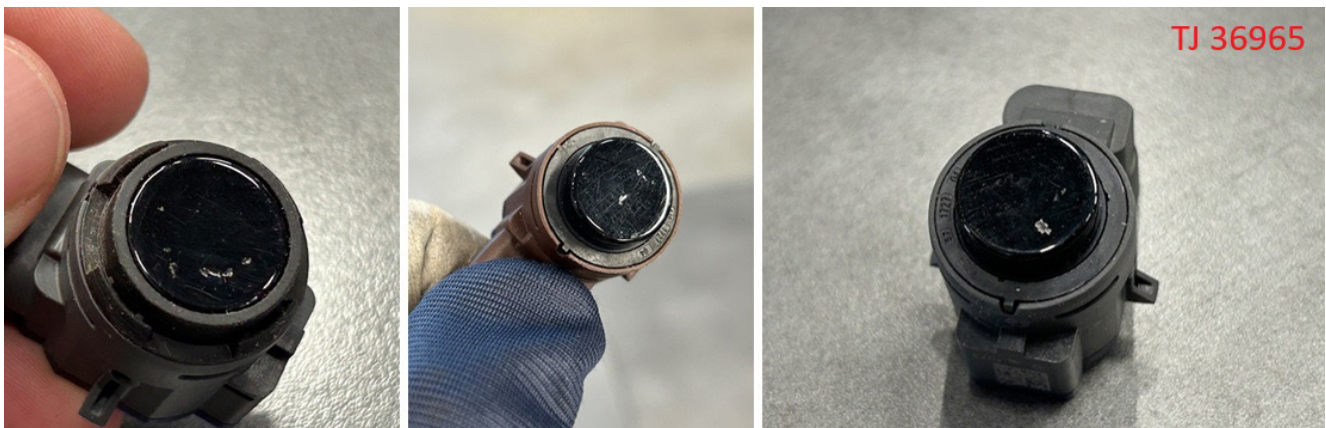
| File Name | File Size |
|---|---|
| TJ_36965_1.jpg | 0.1273 MB |

- The sensor membrane can be damaged by stones/blasting and corrosion can occur. This can cause an increased risk of false warnings or missing failure detection.
Remedied by painting or changing the sensor.

* Visible stone chip damage on the PAS-sensor is NOT accepted as warranty, check the attached photo as an example.
