## Volvo Car USA LLC

Technical Journal Title CEL with DTC ECM P001100, P001200, P001400, P001500		Ref. No. TJ 37148.5.0	
Issuer (Dept.) Technical Service		Issue Date 5/9/25	Status Date 5/16/25
Car Market United States and Canada	Partner 3 US 7510 Volvo Car USA	Function Group 2154	
Function Description Camshaft		Page Page 1 of 4

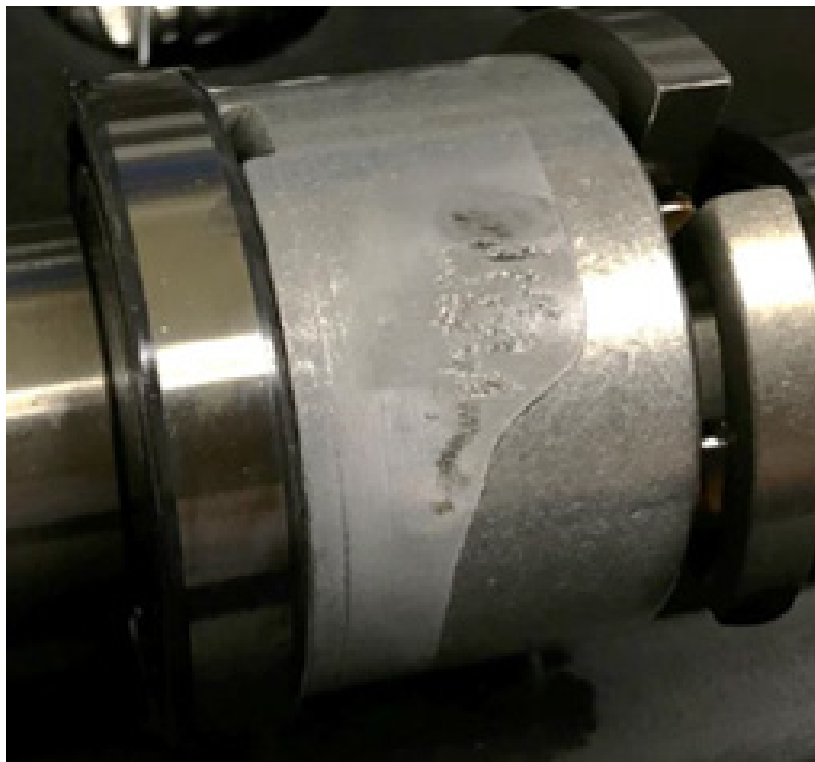
Wear on the outside of the camshaft is not a reason to replace the part. Compare with the attached file TJ\_36920\_1.PNG.
