STAR ONLINE PUBLICATION

Case Number: S2508000056

Release Date: July 2025

Symptom/Vehicle Issue: 12v Ignition Off Draw (IOD) Caused By Power Electronics Coolant Pump 1 (PECP-1) Continuously Running When Vehicle Is Asleep

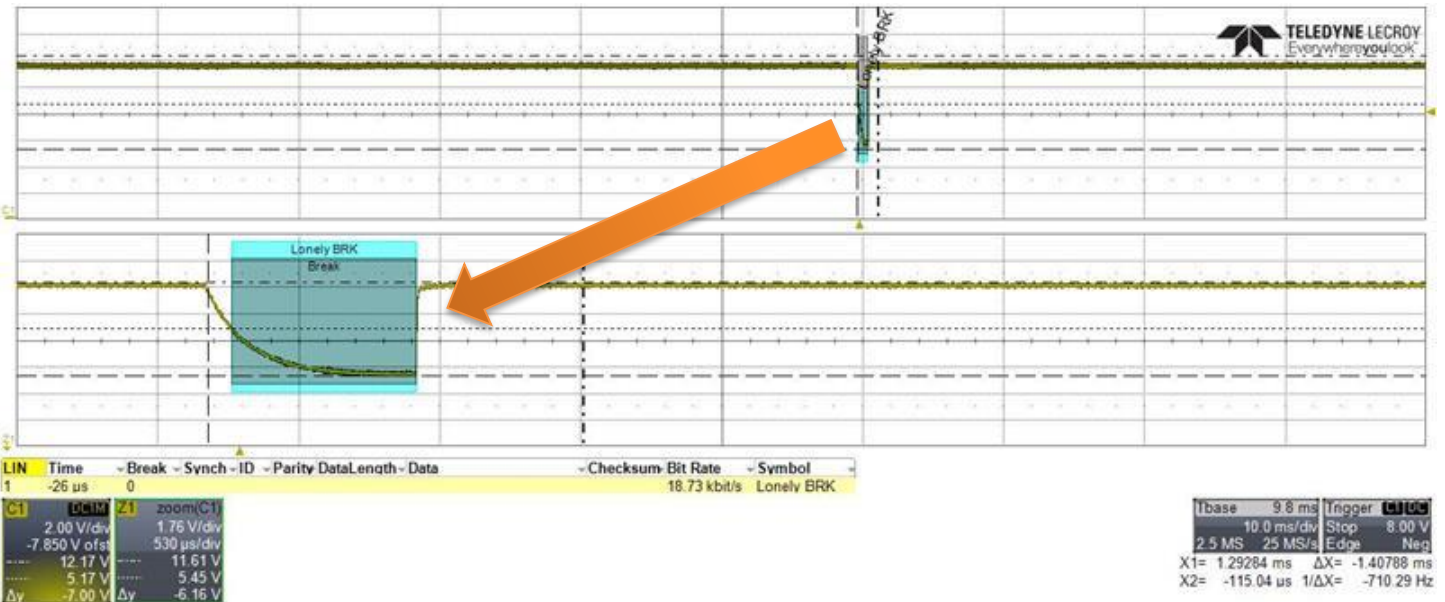
The example above shows a normal view (top) and zoomed in view (bottom) of the same unintentional LIN wake up command, dropping from 11.6v to 5.15v. This unintended wakeup command is only 5 milliseconds or 0.005 seconds long. Reviewing the recording will be necessary to identify.

If you observe the LIN wakeup command occurring after cycling the ignition OFF causing PECP-1 to run and no change when disconnecting the EAC. You will need to individually disconnect each component from LIN 2 to identify which one is providing the unintentional wake up command. Besides the EAC, the Auxiliary High Temperature Heat Pump is the other most likely cause as it is provided B+ at all times. Though malfunction of the Low Temp Expansion Valve, EVCU and wiring are also a possibility.

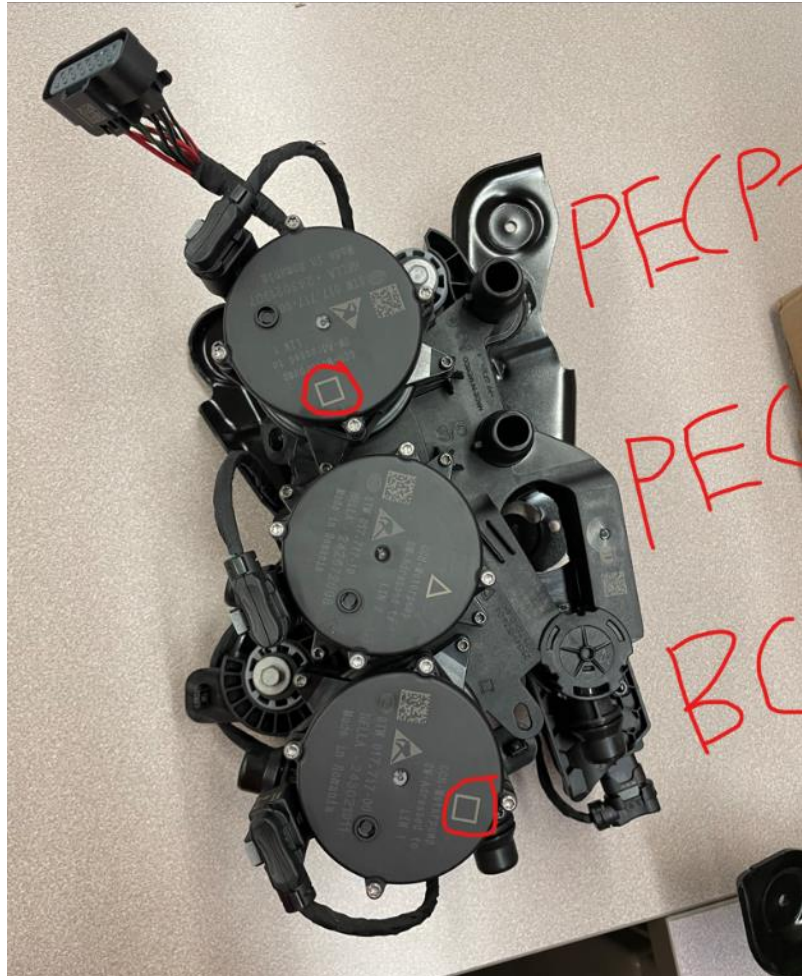
Pictured above you can see the coolant pump assembly with three individual pumps. They communicate with the EVCU on three separate LIN buses. While these pumps are all keyed and physically the same, each pump has a unique part number and contains unique software for identification over their respective LIN bus. The circuit color for Power, Ground and LIN are identical across all three pumps. PECP-1 and BCP have the same square symbol. While PECP-2 has a triangle symbol. Engineering is planning to make these symbols unique for easier identification (no ETA). By referencing the above image and noting the location of the pumps on the assembly bracket, you should be able to identify the location of PECP-1 on vehicle.
