<b>REFERENCE:</b>	<b>TSB:</b> 08-026-25 REV. C <b>GROUP:</b> 08 - Electrical	<b>Date:</b>	July 2, 2025	<b>REVISION:</b>	08-026-25 REV. B
<b>VEHICLES AFFECTED:</b>	<b>2024 (LB) Dodge Charger</b> <b>This bulletin applies to vehicles equipped with 400V G2500 FR/RR Elec Drive Motors (Sales Code ELD).</b>			<b>MARKET APPLICABILITY:</b> <input checked="" type="checkbox"/> NA <input checked="" type="checkbox"/> MEA <input checked="" type="checkbox"/> SA <input checked="" type="checkbox"/> IAP <input checked="" type="checkbox"/> EE <input checked="" type="checkbox"/> CH  <b>NOTE: **This bulletin applies to North and South America, Enlarged Europe, Middle East &amp; Africa, India &amp; Asia Pacific and China markets.**</b>	
<b>CUSTOMER SYMPTOM:</b>	<p><b>Customers may experience a Malfunction Indicator Lamp (MIL) illumination and the vehicle may exhibit/set one or more of the following Diagnostic Trouble Codes (DTCs):</b></p> <ul style="list-style-type: none"> <li>● <b>**C10FA-00 - Wheel Hub disconnect Actuator Performance Left.</b></li> <li>● <b>C10FB-00 - Wheel Hub disconnect Actuator Performance Right.**</b></li> <li>● <b>C10F8-00 - Left Front Wheel Hub Disconnect Actuator Position Senso

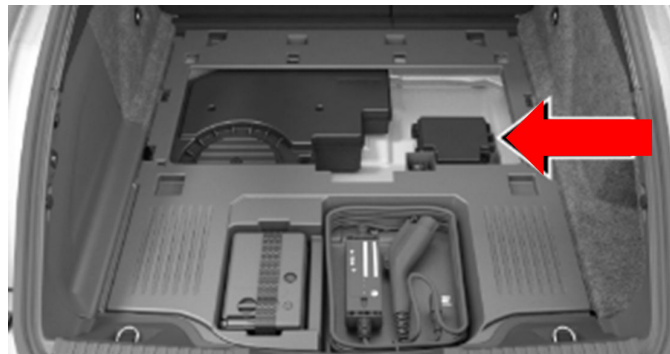
**Fig. 2**  
Rear PDC Location

5. From the rear of the vehicle, pull back the carpet to access the rear Power Distribution Center (PDC) [Fig. 2](#).

24. Install the #38 AGSM fuse [Fig. 3](#) and the PDC cover [Fig. 2](#).
25. Position the rear carpet in place.
26. Connect the cooling fan wire harness connector [Fig. 1](#).
27. Install the front storage bin. Refer to the detailed service procedures available in DealerCONNECT/ ServiceLibrary under: Service Info> 23 - Body / Exterior / Bin, Storage / Installation.
28. Clear any DTCs that may have been set in any modules due to reprogramming. The wiTECH application will automatically present all DTCs after the flash and allow them to be cleared.

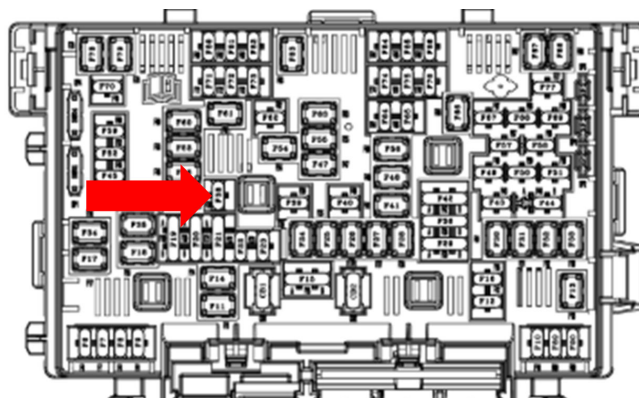
**Fig. 3**  
#38 AGSM Fuse Location

**Failure to remove the #38 AGSM fuse will result in damage to the shifter.**

6. Remove the PDC cover, locate and remove the #38 AGSM fuse [Fig. 3](#).
