REFERENCE:	TSB: 08-028-25 REV. C GROUP: 08 - Electrical	Date:	July 2, 2025	REVISION:	08-028-25 REV. B						
VEHICLES AFFECTED:	<p>2025 (LB) Dodge Charger This bulletin applies to vehicles built on or before April 03, 2025 (MDH 0403XX) equipped with 400V G2500 FR/RR Elec Drive Motors (Sales Code ELD).</p>			<p>MARKET APPLICABILITY:</p>

This bulletin involves reprogramming the IDCM, BPCM, MCP A, MCP B and the EVCU with the latest available software and then, if needed, performing a Wheel End Disconnect Position Learn routine.

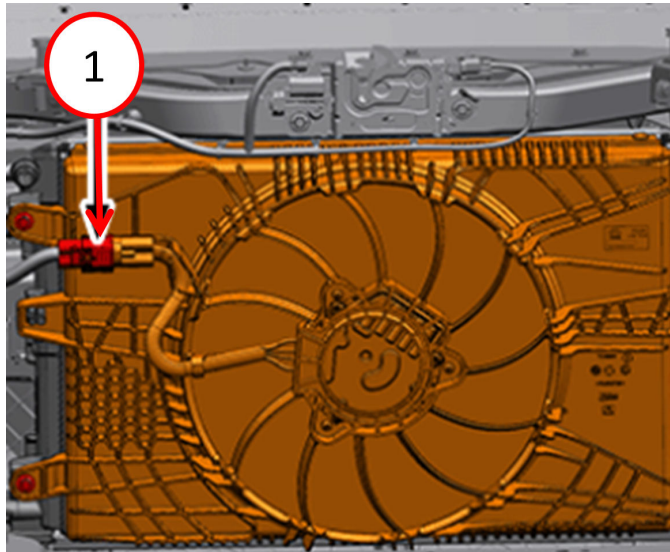
Fig. 1
Cooling Fan Assembly

NOTE: The cooling fan must be disconnected to prevent it from powering on, which may interrupt/ abort the flash process.

1 - Wire Harness To Disconnect/Connect

4. Disconnect the cooling fan wire harness connector [Fig. 1](#).

24. Install the #38 AGSM fuse [Fig. 3](#) and the PDC cover [Fig. 2](#).
25. Position the rear carpet in place.
26. Connect the cooling fan wire harness connector [Fig. 1](#).
27. Install the front storage bin. Refer to the detailed service procedures available in DealerCONNECT/ ServiceLibrary under: Service Info> 23 - Body / Exterior / Bin, Storage / Installation.
28. Clear any DTCs that may have been set in any modules due to reprogramming. The wiTECH application will automatically present all DTCs after the flash and allow them to be cleared.

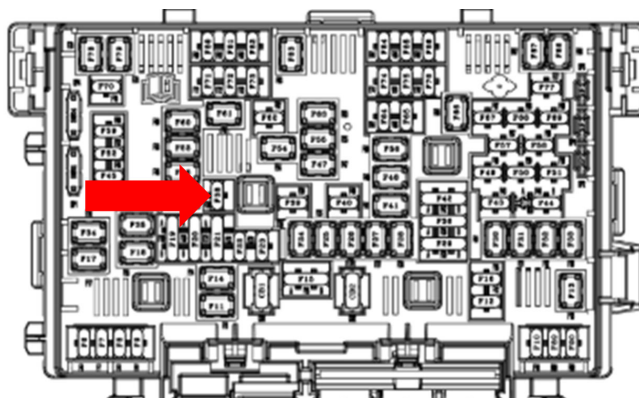
Fig. 3
#38 AGSM Fuse Location

Failure to remove the #38 AGSM fuse will result in damage to the shifter.

6. Remove the PDC cover, locate and remove the #38 AGSM fuse [Fig. 3](#).
