**Technical Service Bulletin (TSB)**  
**RSU With Additional Sleep Cycles for HV Battery Integrity Check**  
**- Flash: Electronic Vehicle Control Unit (EVCU) Updates 11A2**

<b>REFERENCE:</b>	<b>TSB:</b> 08-075-25 REV. B <b>GROUP:</b> 08 - Electrical	<b>Date:</b>	July 2, 2025	<b>REVISION:</b>	08-075-25 REV. A
<b>VEHICLES AFFECTED:</b>	<b>2024 (LB) Dodge Charger</b> <b>This bulletin applies to vehicles equipped with 400V G2500 FR/RR Elec Drive Motors (Sales Code ELD).</b>			<b>MARKET APPLICABILITY:</b> <input checked="" type="checkbox"/> NA <input checked="" type="checkbox"/> MEA <input checked="" type="checkbox"/> SA <input checked="" type="checkbox"/> IAP <input checked="" type="checkbox"/> EE <input checked="" type="checkbox"/> CH <b>NOTE: **This bulletin applies to North and South America, Enlarged Europe, Middle East &amp; Africa, India &amp; Asia Pacific and China markets.**</b>	
<b>CUSTOMER SYMPTOM:</b>	<p><b>Customers may experience a Malfunction Indicator Lamp (MIL) illumination and the vehicle may exhibit/set one or more of the following Diagnostic Trouble Codes (DTCs):</b></p> <ul style="list-style-type: none"> <li>• <b>**C10FA-00 - Wheel Hub disconnect Actuator Performa

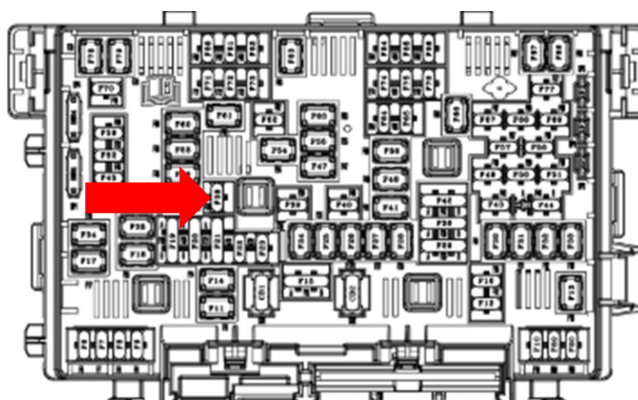
**Fig. 3**  
#38 AGSM Fuse Location

**Failure to remove the #38 AGSM fuse will result in damage to the shifter.**

6. Remove the PDC cover, locate and remove the #38 AGSM fuse [Fig. 3](#).

24. Install the #38 AGSM fuse [Fig. 3](#) and the PDC cover [Fig. 2](#).
