REFERENCE:	TSB: 08-204-25 GROUP: 08 - Electrical	Date:	July 2, 2025	REVISION:	—
VEHICLES AFFECTED:	2024 (LB) Dodge Charger This bulletin applies to vehicles equipped with 400V G2500 FR/RR Elec Drive Motors (Sales Code ELD).			MARKET APPLICABILITY: <input checked="" type="checkbox"/> NA <input checked="" type="checkbox"/> MEA <input checked="" type="checkbox"/> SA <input checked="" type="checkbox"/> IAP <input checked="" type="checkbox"/> EE <input checked="" type="checkbox"/> CH NOTE: This bulletin applies to North and South America, Enlarged Europe, Middle East & Africa, India & Asia Pacific and China markets.	
CUSTOMER SYMPTOM:	Customers may experience a Malfunction Indicator Lamp (MIL) illumination and the vehicle may exhibit/set one or more of the following Diagnostic Trouble Codes (DTCs): <ul style="list-style-type: none"> • C10FA-00 - Wheel Hub disconnect Actuator Performance Left. • C10FB-00 - Wheel Hub disconnect Actuator Performance Right. Customers may also comment on the following: <ul style="list-style-type: none"> • Wrench icon is illuminated on the Instrument Panel Cluster (IPC).

CAUSE:	EVCU software update

This bulletin involves reprogramming the EVCU with the late

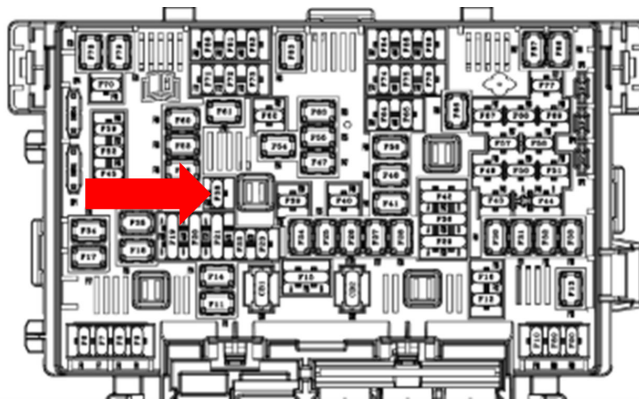
Fig. 2

#38 AGSM Fuse Location

2. Remove the PDC cover, locate and remove the #38 AGSM fuse [Fig. 2](#).

12. Install the #38 AGSM fuse [Fig. 2](#) and the PDC cover [Fig. 1](#).
13. Position the rear carpet in place.
14. Clear any DTCs that may have been set in any modules due to reprogramming. The wiTECH application will automatically present all DTCs after the flash and allow them to be cleared.
