REFERENCE:	TSB: 08-205-25 GROUP: 08 - Electrical	Date:	July 2, 2025	REVISION:	—
VEHICLES AFFECTED:	2025 (LB) Dodge Charger This bulletin applies to vehicles built on or before April 03, 2025 (MDH 0403XX) equipped with 400V G2500 FR/RR Elec Drive Motors (Sales Code ELD).			MARKET APPLICABILITY: <input checked="" type="checkbox"/> NA <input checked="" type="checkbox"/> MEA <input checked="" type="checkbox"/> SA <input checked="" type="checkbox"/> IAP <input checked="" type="checkbox"/> EE <input checked="" type="checkbox"/> CH NOTE: This bulletin applies to North and South America, Enlarged Europe, Middle East & Africa, India & Asia Pacific and China markets.	
CUSTOMER SYMPTOM:	Customers may experience a Malfunction Indicator Lamp (MIL) illumination and the vehicle may exhibit/set one or more of the following Diagnostic Trouble Codes (DTCs): <ul style="list-style-type: none"> • C10FA-00 - Wheel Hub disconnect Actuator Performance Left. • C10FB-00 - Wheel Hub disconnect Actuator Performance Right. Customers may also comment on the following: <ul style="list-style-type: none"> • Wrench icon is illuminated on the Instrument Panel Cluster (IPC).

CAUSE:	EVCU software update

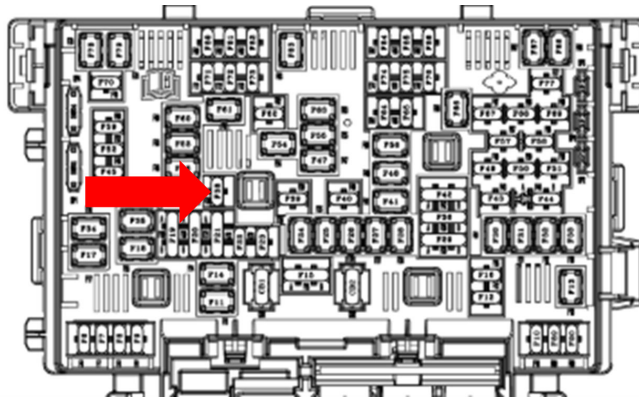
Fig. 2

#38 AGSM Fuse Location

2. Remove the PDC cover, locate and remove the #38 AGSM fuse [Fig. 2](#).

12. Install the #38 AGSM fuse [Fig. 2](#) and the PDC cover [Fig. 1](#).
13. Position the rear carpet in place.
14. Clear any DTCs that may have been set in any modules due to reprogramming. The wiTECH application will automatically present all DTCs after the flash and allow them to be cleared.
