Technical Service Bulletin (TSB)
R1L Radio Over The Air Update
From 62.00.23 To 62.00.29 Software Version

REFERENCE:	TSB: 08-208-25 GROUP: 08 - Electrical	Date:	July 3, 2025	REVISION:	-
VEHICLES AFFECTED:	2021 - 2025 (B1) Jeep Renegade This bulletin applies to vehicles built on or before February 03, 2025 (MDH 0203XX) equipped with a Global Telematics Box Module (Sales Code RDG) and Uconnect 5 NAV W 8.4" DISP (ROW-DAB) (Sales Code UPL).			MARKET APPLICABILITY: <input type="checkbox"/> NA <input type="checkbox"/> MEA <input checked="" type="checkbox"/> SA <input type="checkbox"/> IAP <input type="checkbox"/> EE <input type="checkbox"/> CH NOTE: This bulletin applies to South America markets.	
CUSTOMER SYMPTOM:	Customers will not experience any symptoms. <ul style="list-style-type: none"> New software has been created to support a new radio model. 				
CAUSE:	Supplier change

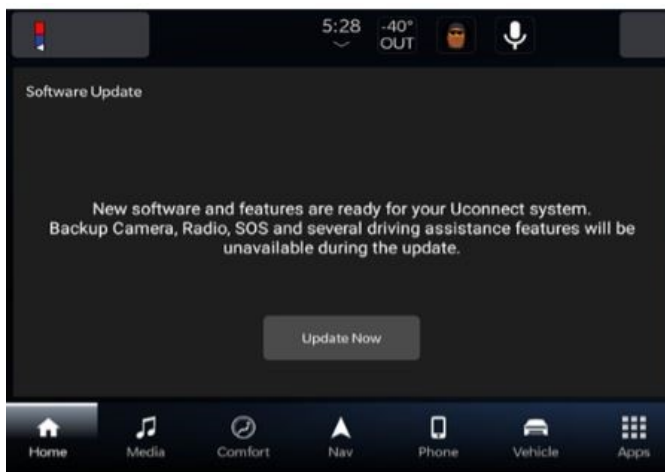
2. If the customer selects “Update Now” they can shut off the vehicle and leave. The update will be completed automatically [Fig. 1](#).

Fig. 1
Software Update Screen

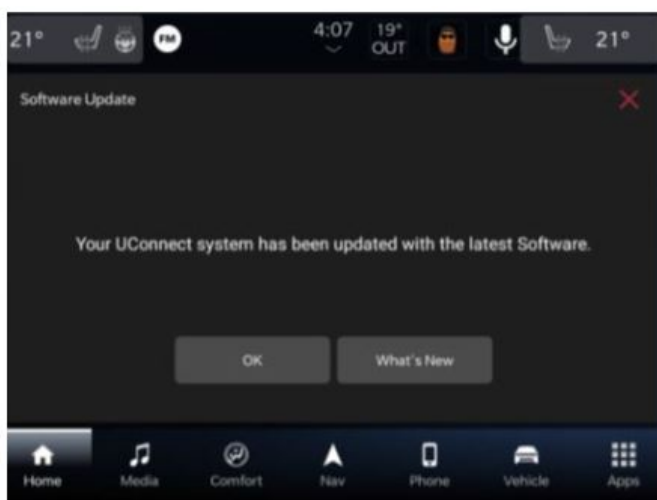
3. Upon completion of update, the radio will display a confirmation message [Fig. 2](#).

Fig. 2
Software Update Confirmation Screen
