**Technical Service Bulletin (TSB)**  
**Improperly Installed Wastegate Rod Retention Clips**

<b>REFERENCE:</b>	<b>TSB:</b> 09-008-25 REV. B <b>GROUP:</b> 09 - Engine	<b>Date:</b>	July 2, 2025	<b>REVISION:</b>	09-008-25 REV. A
<b>VEHICLES AFFECTED:</b>	<b>2025 (DT) RAM 1500 Pickup</b> This bulletin applies to vehicles built on or after June 01, 2024 (MDH 0601XX) and on or before March 03, 2025 (MDH 0325XX) equipped with the 3.0L I6 Hurricane HO Twin Turbo ESS (Sales Code EFC).			<b>MARKET APPLICABILITY:</b> <input checked="" type="checkbox"/> NA <input type="checkbox"/> MEA <input type="checkbox"/> EE <input type="checkbox"/> IAP <input type="checkbox"/> SA <input type="checkbox"/> CH <b>NOTE: **This bulletin applies to North America markets.</b> **	
<b>CUSTOMER SYMPTOM:</b>	Customers must experience a Malfunction Indicator Lamp (MIL) illumination and the vehicle must exhibit/set one or more of the following Diagnostic Trouble Codes (DTCs): <ul style="list-style-type: none"> <li>• P0248-00 - Turbocharger-Supercharger Wastegate Actuator B Range-performance.</li> <li>• P2B94-00 - Wastegate Position Sensor B Exceeded Learning Limit.</li> </ul> Customers may also experience the follow

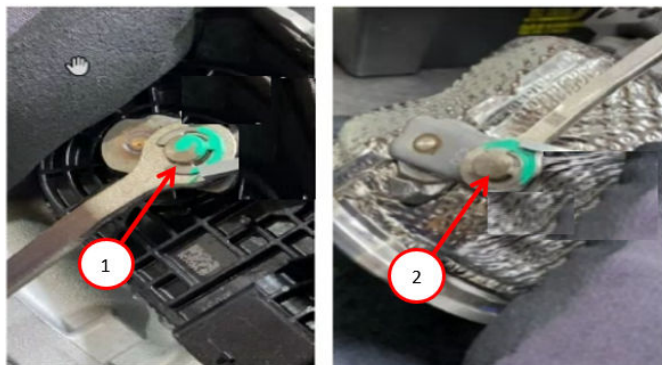
**Fig. 1**  
Wastegate Rod Retaining Clips

<b>CAUSE:</b>	Incorrectly installed wastegate rod retention clips

1 - Actuator Side Wastegate Rod Retaining Clip  
2 - Housing Side Wastegate Rod Retaining Clip\*\*

4. Is the measurement of either wastegate rod retaining clip on the actuator side greater than 13.70 mm **\*\* (0.538 in.)\*\***?
  - YES>>> Proceed to [Step 5](#).

6. Using a caliper, measure the dimensions of the two wastegate rod retaining clips on the housing side [Fig. 1](#).
7. Is the measurement of either of the wastegate rod retaining clips on the housing side greater than 17.78 mm (0.7 in.)?

- NO>>> Proceed to [Step 6](#).
5. Replace any wastegate rod retaining clip on the actuator side that measures larger than 13.70 mm **\*\* (0.538 in.)\*\***.

8. Replace any wastegate rod retaining clip on the housing side that measures larger than 17.78 mm (0.7 in.).
9. Install the clean air tube. Refer to the detailed service procedures available in DealerCONNECT/Service Library under: Service Info> 09 - Engine, 3.0L GMET6 / Air Intake System / Tube, Intake Air / Installation.
