Model Series 463 AMG: Active Distance Assist and Active Brake Assist IC Message and DTC U0416FE

Topic number	LI54.71-P-078112
Version	4
Function group	54.71 - Camera and radar-assisted assistance systems
Date	7/8/25
Validity	463 AMG
Reason for change	Adding parts for wiring.

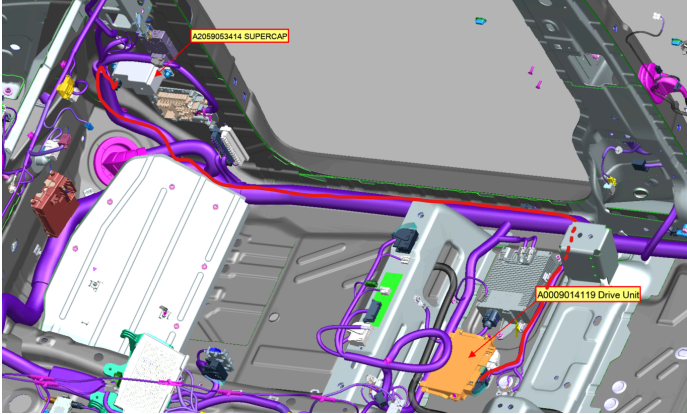
Picture 1 - Connection from Supercap to Drive Unit
wire+routing+Supercap+to+DriveUnit.png

Missing wire between Drive Unit (N145) and Supercap (C8).

- Using a red/white cable with cross-section 0.35 mm² and overall length of approximately 2m.
- Connect Drive Unit (N145) plug A pin 18 to the 3-pin plug of the Supercap (C8) terminal 15 pin 2. Reference the new wire routing location as shown by the red line in "Picture 1 - Connection from Supercap to Drive Unit".
- The new wire should be added to the existing wiring harness as shown by the red line "Picture 1 - Connection from Supercap to Drive Unit".
- Z-Splice is the preferred method using A 000 982 91 10.
- Crimp Contact Pin (MLK) for the Drive Unit (N145) is A0485450328.
