TECHNICAL INSTRUCTIONS

SPECIAL SERVICE CAMPAIGN 25TC07

Blind Spot Monitor System Reprogramming

CERTAIN 2024 Model Year Tacoma and Tacoma HV

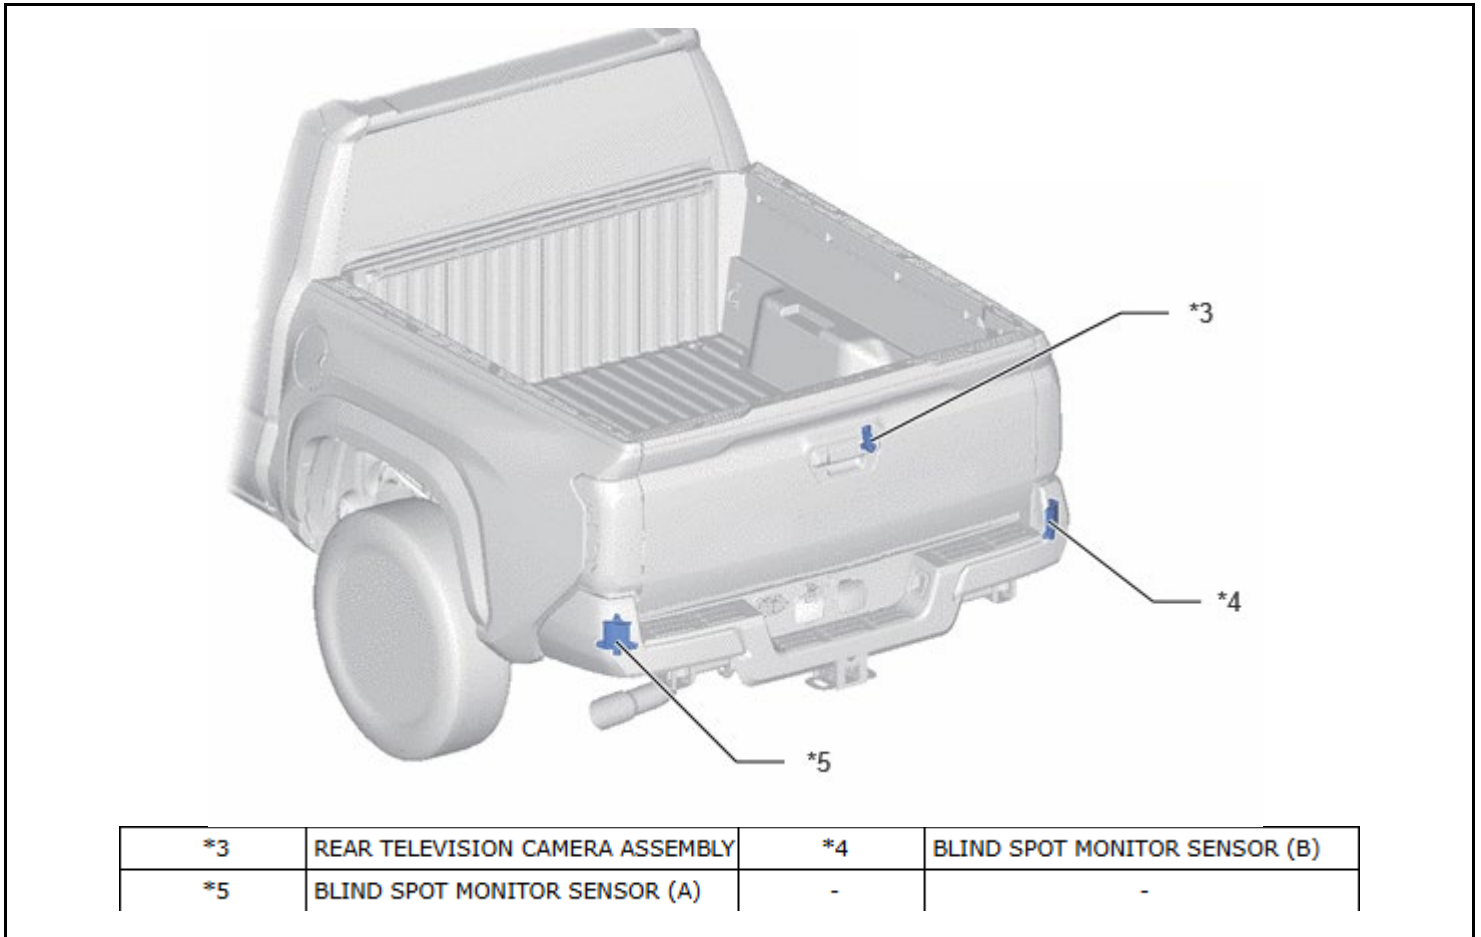
The subject vehicles are equipped with a Trailer Blind Spot Monitor (TBSM) system, which consists of two Blind Spot Monitor (BSM) sensors. Due to the programming of the BSM sensors, the TBSM system may not be able to detect the extended area for the trailer under certain operating conditions as described in the owner's manual.

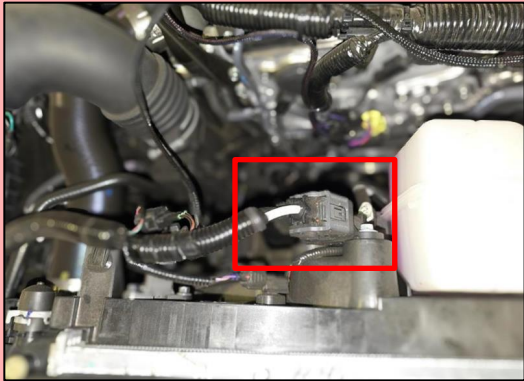
Front of Vehicle

Notice: • If you reprogram without disconnecting the cooling fan motor connector, the electric fan operates during reprogramming, causing a decrease of the battery voltage and the reprogramming processes will be disabled. This may result in damage of the ECU.

2. DISCONNECT THE COOLING FAN MOTOR CONNECTOR.

•After disconnecting the cooling fan motor connector, make sure that dirt, water or other foreign matter does not contact the cooling fan motor connector.

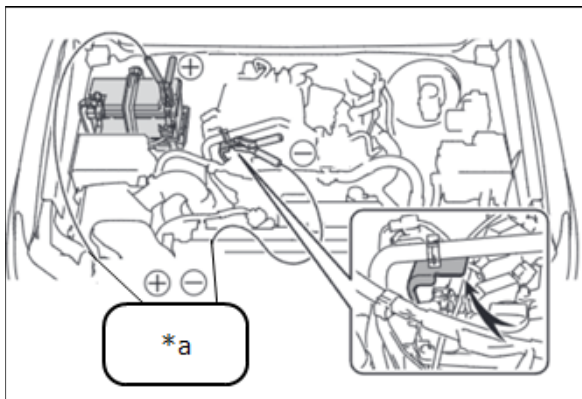
A power supply MUST be used during reprogramming. ECU damage will occur if the battery voltage is not properly maintained during this re-flash procedure.

3. CONNECT THE 12V BATTERY TO A POWER SUPPLY

- a) Connect the DCA-8000 or other type of power supply (not a battery charger) to the 12 V battery.
- b) Tap the Reflash icon from the Main Menu screen of the DCA-8000.

A power supply must be connected directly to the 12V battery terminals and NOT the remote jump posts under the hood (if equipped).
