Subject		Market	
Installation Tip for Seat Side Shield		USA	
Service Category		Section	
Vehicle Interior		Seat	
Applicability			
2022-2025 Tundra Tundra HV Sequoia HV

**Seat Side Shield Cracking on lower portion after replacement using latest parts**

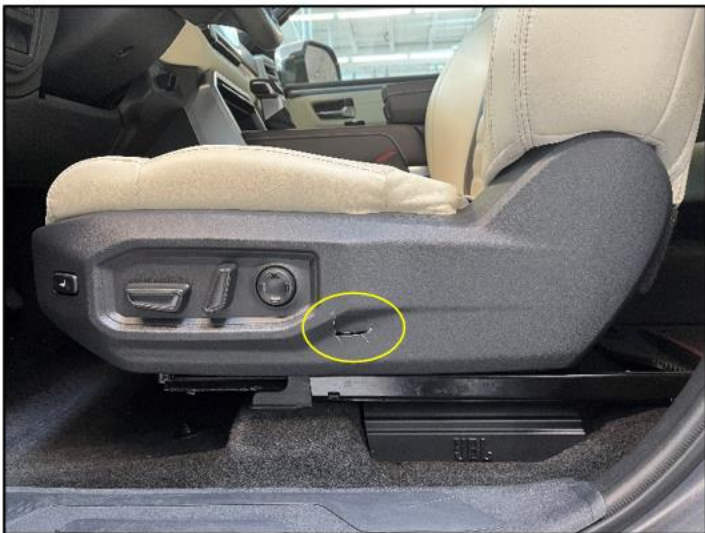
Customers may experience the front seat side shield cracking on the lower portion as shown on figure 1. The lower clip attachment point may not be seated due to mispositioning during shield installation. If not properly aligned during installation clip will shift up and sit on top of attachment point as shown on figure 2.

Figure 1: Side shield cracking View

Re-install of the seat cushion side shield by following the repair manual instructions listed in the link references below.

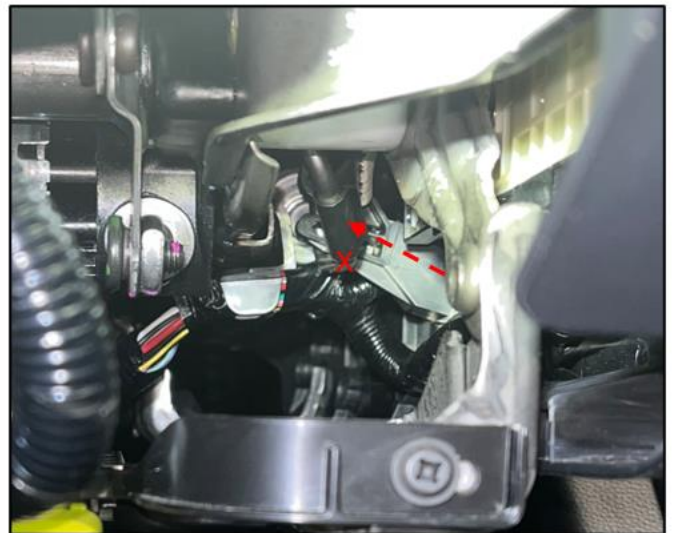
Figure 2: 3<sup>rd</sup> clip mis-installed

For aid during installment procedure, view videos 1-3 clip installation for verification of good engagement .

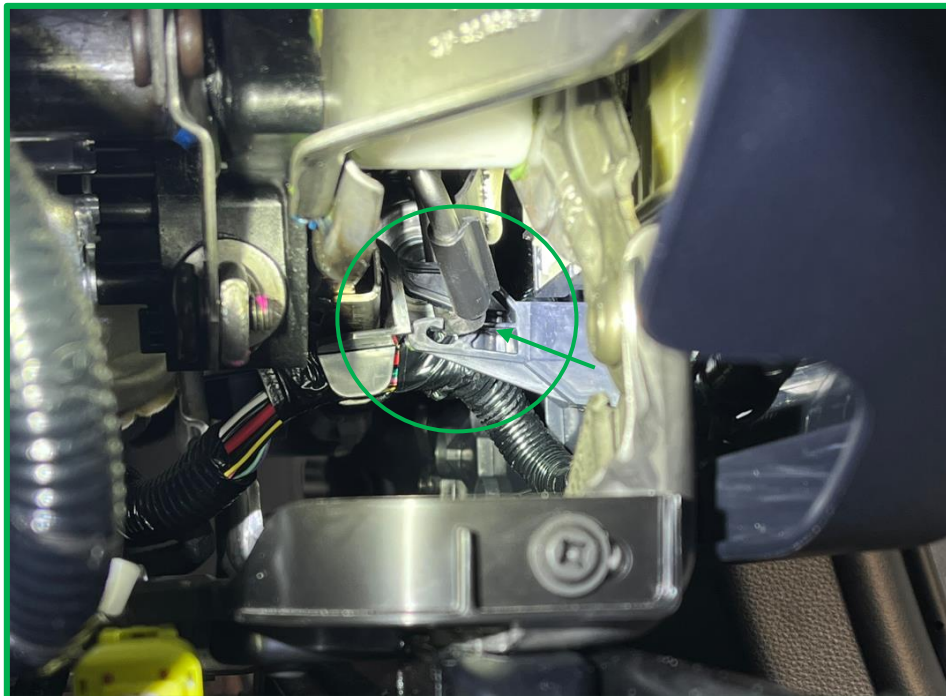
Shield Lower Clip – How to inspect

Figure 3: Lower attachment clip fully engaged in position.

Note: Inspection is made from the front looking under the seat point of view.

Note: This condition may happen again if new seat shield replacement is not installed properly. It is strongly recommended to perform visual check after installation to confirm attachment clip is fully engaged. See figure 3 for illustration.
