# Engine Oil Level Low Warning Message on MID

**Service Category**   Engine/Hybrid System

**Section**   Lubrication

| YEAR(S) | MODEL(S) | ADDITIONAL INFORMATION |
|---|---|---|
| 2025 | Camry HV | |

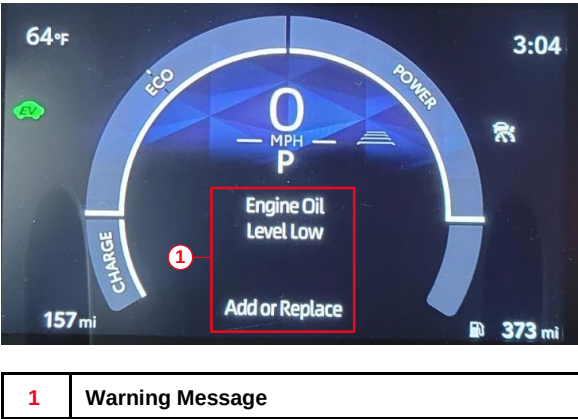
**Figure 1.**

Some 2025 model year Camry Hybrid vehicles may display an “Engine Oil Level Low” warning message on the Multi-information Display (MID) and/or the head unit. This condition occurs despite the gauge showing an adequate oil level. No Diagnostic Trouble Codes (DTCs) are associated with this condition. Follow the Repair Procedure in this bulletin to address this condition.

5. Replace the camshaft housing sub-assy.
