# Service Bulletin

Bulletin No.: PIT6379A

**Subject: Radio Stability Issues After Carplay Use**

Brand:	Model:	Model Year:		VIN:		Engine:	Transmission:
		from	to	from	to		
Chevrolet	Colorado	2025		All	All	All	All
GMC	Canyon	2025		All	All	All	All

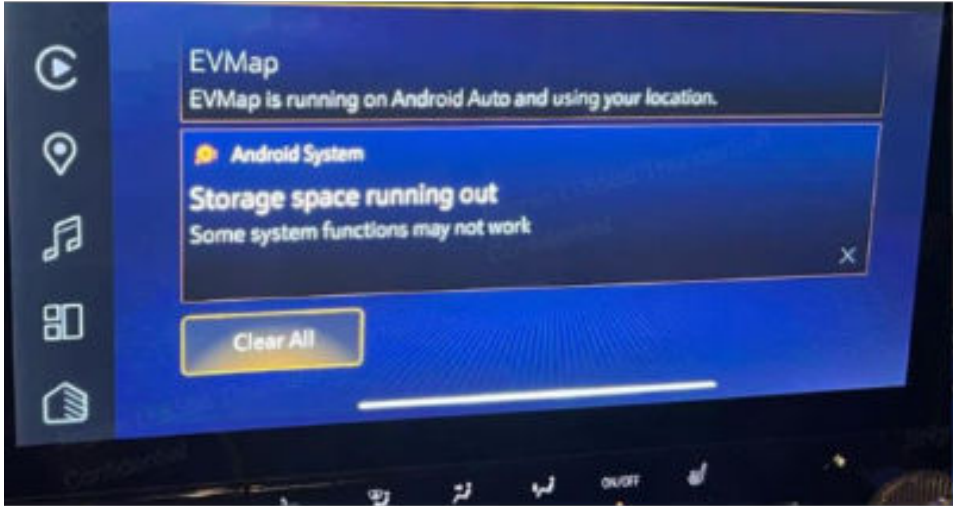
<p style="text-align: right;">6932358</p>
<p><b>Cause</b></p>	<p>This may be due to a software anomaly.</p>

<p><b>Condition</b></p>	<p>A customer may comment that after using CarPlay their radio has stability issues. These could include:                      Intermittent blank radio screen with HVAC and vehicle controls still showing.                      CarPlay audio may stop or disconnect.                      Rebooting of the radio.                      Slow to boot – including seeing “Android is Starting” on the radio.                      Message below about storage space.                      Performing a factory reset – including losing radio favorites and phone pairings.</p>
