GENERAL MOTORS  
DCS7265  
URGENT - DISTRIBUTE IMMEDIATELY

Subject: N252512260 - Service Update  
Suspect Torque on Steering I-Shaft Fastener

Models: 2024-2026 Chevrolet Silverado EV  
2025 GMC Sierra EV

### N252512260 Suspect Torque on Steering I-Shaft Fastener

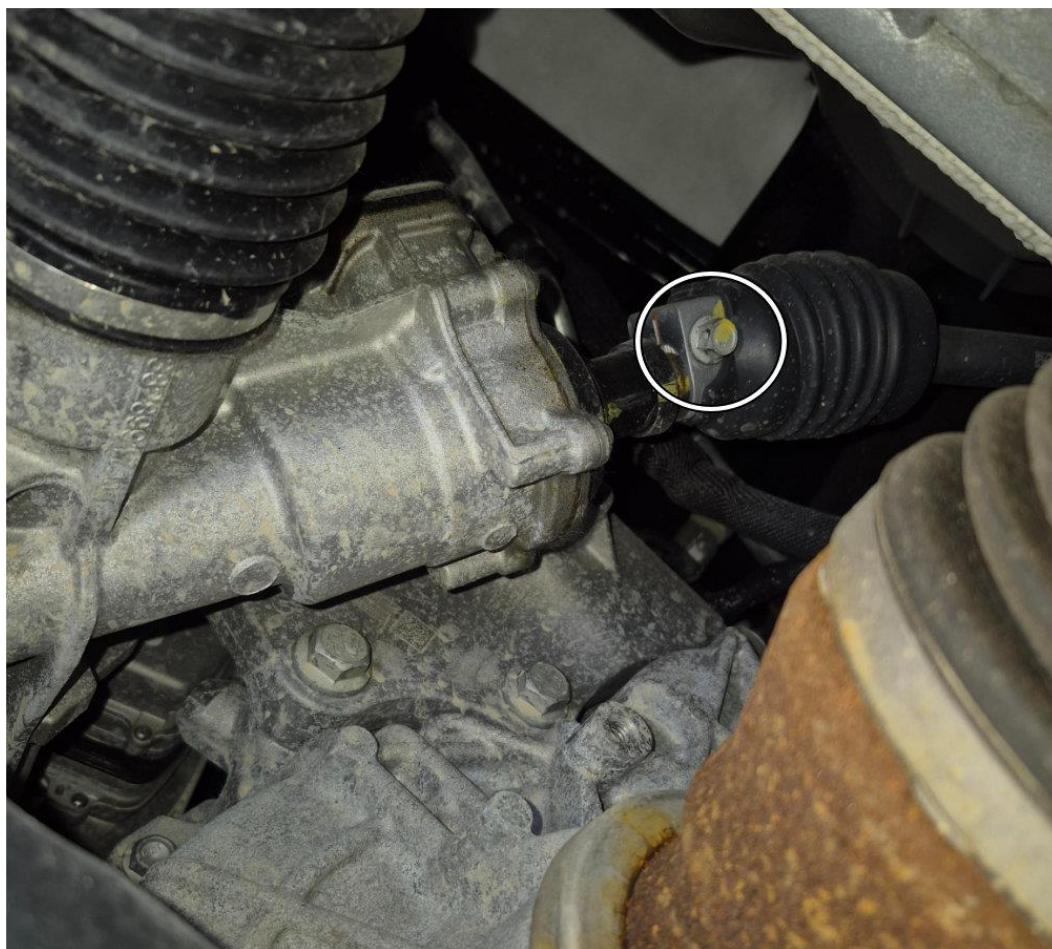
6982079

| <b>Condition</b> | Certain vehicles listed above may have a condition in which the fastener for the intermediate steering shaft to steering gear assembly may have suspect torque results. |

3. Replace the intermediate steering shaft bolt. Torque to 37 ft-lbs (50N-m).
4. Reinstall the Front Compartment Air Deflector. Refer to *Front Compartment Air Deflector Replacement* in SI.
5. Lower the vehicle. Refer to *Lifting and Jacking the Vehicle* in SI.
