Technical Service Bulletin (TSB)
Incorrectly Routed Wheel Speed Sensor Wiring

REFERENCE:	TSB: 05-003-25 GROUP: 05 - Brakes	Date:	July 11, 2025	REVISION:	–
VEHICLES AFFECTED:	2025 (DP) RAM 4500/5500 Cab Chassis This bulletin applies to vehicles built on or after February 05, 2025 (MDH 0205XX) and on or before March 31, 2025 (MDH 0331XX) equipped with a 6.4L V8 HEMI Upgrade HD Engine (Sales Code ESL).			MARKET APPLICABILITY: <input checked="" type="checkbox"/> NA <input type="checkbox"/> MEA <input type="checkbox"/> SA <input type="checkbox"/> IAP <input type="checkbox"/> EE <input type="checkbox"/> CH NOTE: This bulletin applies to North America markets.	
CUSTOMER SYMPTOM:	Customers must experience a Malfunction Indicator Lamp (MIL) illumination and the vehicle must exhibit/set the following Diagnostic Trouble Code (DTC): <ul style="list-style-type: none"> • C0031-1D - Left Front Wheel Speed Sensor - Circuit Current Out Of Range. Customers may comment on one or more of the following: <ul style="list-style-type: none"> • Brake warning indicator illuminated on the Instrument Panel Cluster (IPC). • Electronic Stability Control (ESC) indicator is illuminated.

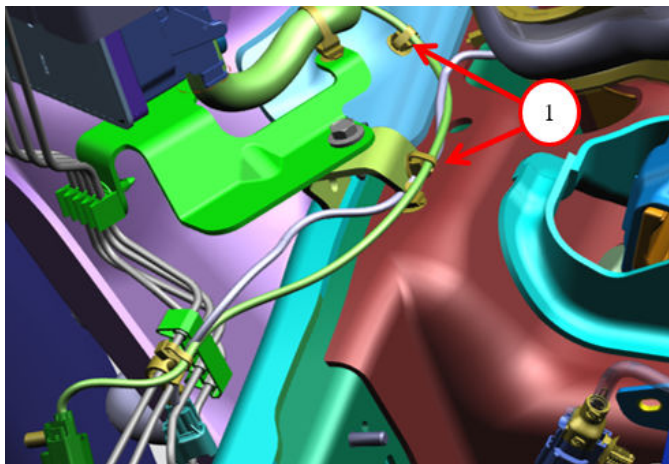
Fig. 3
Wheel Speed Sensor Wiring Routing

1 - Incorrectly Routed Wheel Speed Sensor Wiring And Clips

4. Is the wheel speed sensor wiring routed correctly [Fig. 3](#)?
 - YES>>> Use Inspection LOP (08-14-18-9J) to close the active RSU and proceed to [Step 15](#).
 - NO>>> Proceed to [Step 5](#).

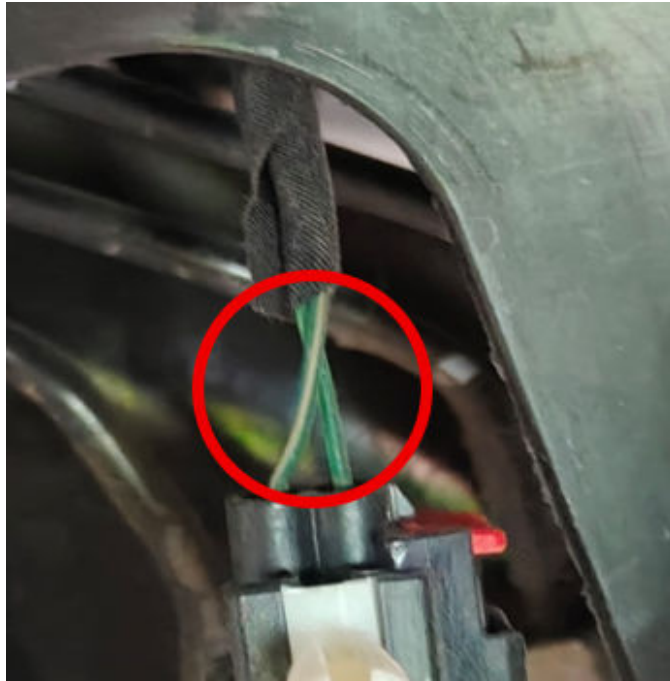
Fig. 5
Area To Inspect For Damaged Wiring

6. Remove the wheel speed sensor wiring clips and inspect the wires for damage between the wire insulation and the harness connector [Fig. 5](#).

7. Is the wheel speed sensor wire damaged between the wire insulation and the harness connector?
- YES>>> Proceed to [Step 8](#).
 - NO>>> Proceed to [Step 9](#).
8. Cut the circuit and replace the damaged section of wiring between the wire insulation and the harness connector.
9. Remove the terminal from the harness connector and solder to the rear section with heat shrink.
10. Install the terminal back to the harness connector.

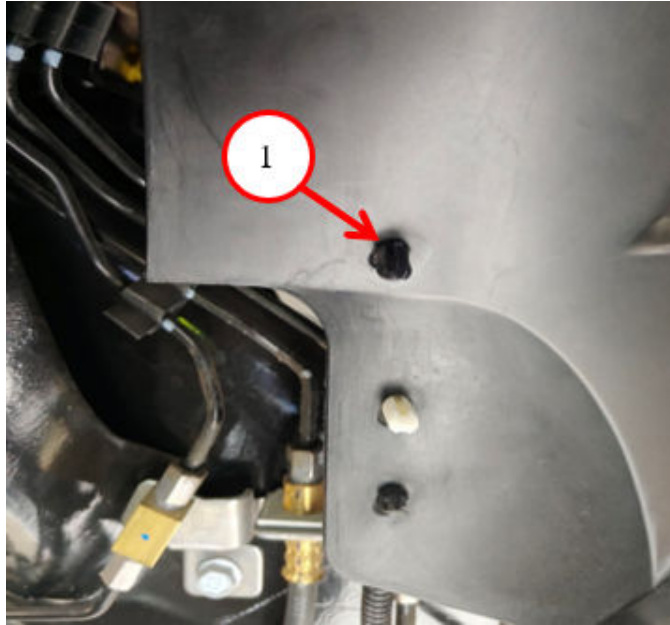
Fig. 8

Back Of Existing Wiring Clip Hole To Confirm Proper Installed Location

12. Install the harness connector with the new wiring clip to the existing hole FIG. Confirm that the clip is located in the correct hole [Fig. 7](#) and [Fig. 9](#).
