REFERENCE:	TSB: 08-011-25 REV. C GROUP: 08 - Electrical	Date:	July 10, 2025	REVISION:	08-011-25 REV. B						
VEHICLES AFFECTED:	<p>2024 (KM) Jeep Wagoneer S This bulletin applies to vehicles equipped with 400V G2500 FR/RR Elec Drive Motors (Sales Code ELD).</p>			<p>MARKET APPLICABILITY:</p>

REPAIR SUMMARY:

This bulletin involves reprogramming the IDCM, BPCM, MCP A, MCP B and the EVCU with the latest available software and then, if needed, performing a Wheel End Disconnect Position Learn routine.

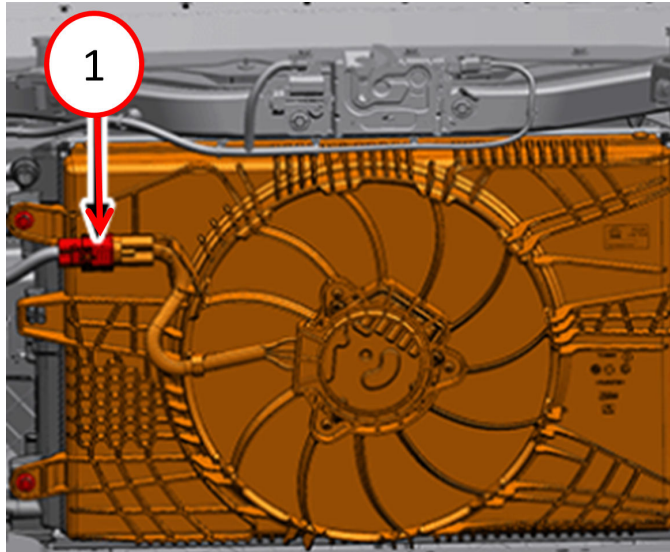
Fig. 1
Cooling Fan Assembly

1 - Wire Harness To Disconnect/Connect

NOTE: The cooling fan must be disconnected to prevent it from powering on, which may interrupt/ abort the flash process.
4. Disconnect the cooling fan wire harness connector [Fig. 1](#).

21. Connect the cooling fan wire harness connector [Fig. 1](#).
