REFERENCE:	TSB: 08-013-25 REV. D GROUP: 08 - Electrical	Date:	July 10, 2025	REVISION:	08-013-25 REV. C
VEHICLES AFFECTED:	2024 (KM) Jeep Wagoneer S This bulletin applies to vehicles equipped with 400V G2500 FR/RR Elec Drive Motors (Sales Code ELD).			MARKET APPLICABILITY:	<input checked="" type="checkbox"/> NA <input checked="" type="checkbox"/> MEA <input checked="" type="checkbox"/> SA <input checked="" type="checkbox"/> IAP <input checked="" type="checkbox"/> EE <input checked="" type="checkbox"/> CH NOTE: **This bulletin applies to North and South America, Enlarged Europe, Middle East & Africa, India & Asia Pacific and China markets.**
CUSTOMER SYMPTOM:	<p>Customers may experience a Malfunction Indicator Lamp (MIL) illumination and the vehicle may exhibit/set the following Diagnostic Trouble Code (DTC):</p> <ul style="list-style-type: none"> • P1626-00 - Park Pawl Motor Stuck. <p>Customers may also comment on one or more of the following:</p> <ul style="list-style-type: none"> • Wrench lamp on in the Instrument Panel Cluster (IPC). • Not able to move the shifter out of Park. • Vehicle has reduced power. <p>This bulletin also includes the following software enhancement:</p> <ul

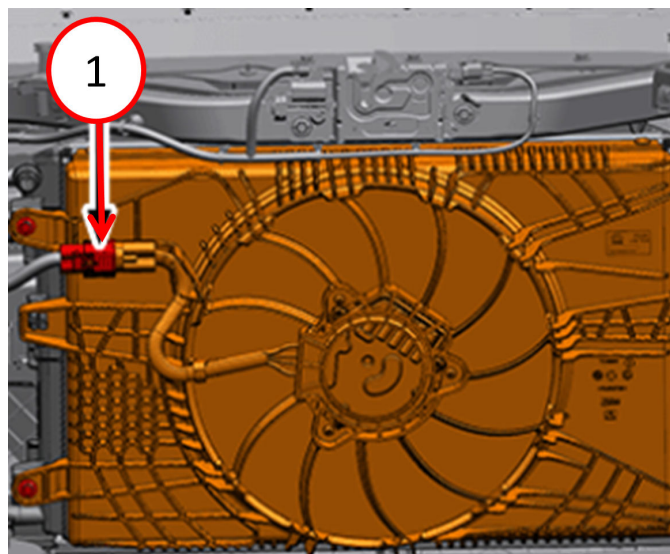
Fig. 1
Cooling Fan Assembly

NOTE: The cooling fan must be disconnected to prevent it from powering on, which may interrupt/ abort the flash process.

4. Disconnect the cooling fan wire harness connector [Fig. 1](#).

21. Connect the cooling fan wire harness connector [Fig. 1](#).
22. Install the front storage bin. Refer to the detailed service procedures available in DealerCONNECT/ ServiceLibrary under: Service Info> 23 - Body / Exterior / Bin, Storage / Installation.
23. Clear any DTCs that may have been set in any modules due to reprogramming. The wiTECH application will automatically present all DTCs after the flash and allow them to be cleared.
