REFERENCE:	TSB: 08-022-25 REV. C GROUP: 08 - Electrical	Date:	July 10, 2025	REVISION:	08-022-25 REV. B						
VEHICLES AFFECTED:	<p>2024 (LB) Dodge Charger This bulletin applies to vehicles equipped with 400V G2500 FR/RR Elec Drive Motors (Sales Code ELD).</p>			<p>MARKET APPLICABILITY:</p>

This bulletin involves reprogramming the IDCM, BPCM, MCP A, MCP B and the EVCU with the latest available software and then, if needed, performing a Wheel End Disconnect Position Learn routine.

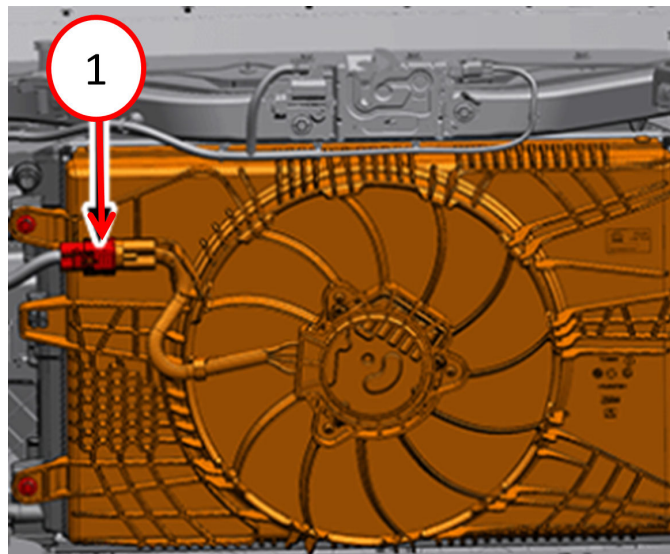
Fig. 1
Cooling Fan Assembly

1 - Wire Harness To Disconnect/Connect

4. Disconnect the cooling fan wire harness connector [Fig. 1](#).

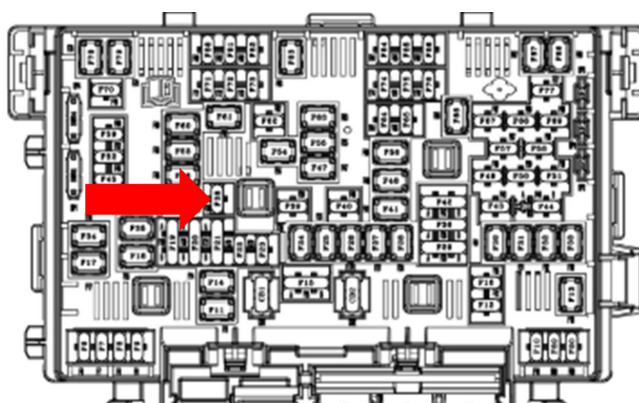
Fig. 3
#38 AGSM Fuse Location

Failure to remove the #38 AGSM fuse will result in damage to the shifter.

- Remove the PDC cover, locate and remove the #38 AGSM fuse [Fig. 3](#).
