<b>REFERENCE:</b>	<b>TSB:</b> 08-024-25 REV. C <b>GROUP:</b> 08 - Electrical	<b>Date:</b>	July 10, 2025	<b>REVISION:</b>	08-024-25 REV. B
<b>VEHICLES AFFECTED:</b>	<b>2025 (LB) Dodge Charger</b> This bulletin applies to vehicles built on and before April 03, 2025 (MDH 0403XX) equipped with 400V G2500 FR/RR Elec Drive Motors (Sales Code ELD).			<b>MARKET APPLICABILITY:</b> <input checked="" type="checkbox"/> NA <input checked="" type="checkbox"/> MEA <input checked="" type="checkbox"/> SA <input checked="" type="checkbox"/> IAP <input checked="" type="checkbox"/> EE <input checked="" type="checkbox"/> CH <b>NOTE: **This bulletin applies to North and South America, Enlarged Europe, Middle East &amp; Africa, India &amp; Asia Pacific and China markets.**</b>	
<b>CUSTOMER SYMPTOM:</b>	Customers must experience a Malfunction Indicator Lamp (MIL) illumination and the vehicle must exhibit/set the following Diagnostic Trouble Code (DTC): <ul style="list-style-type: none"> <li>• P1626-00 - Park Pawl Motor Stuck.</li> </ul> The customer may comment on one or more of the following symptoms: <ul style="list-style-type: none"> <li>• Wrench icon is illuminated on the Instrument Panel Cluster (IPC

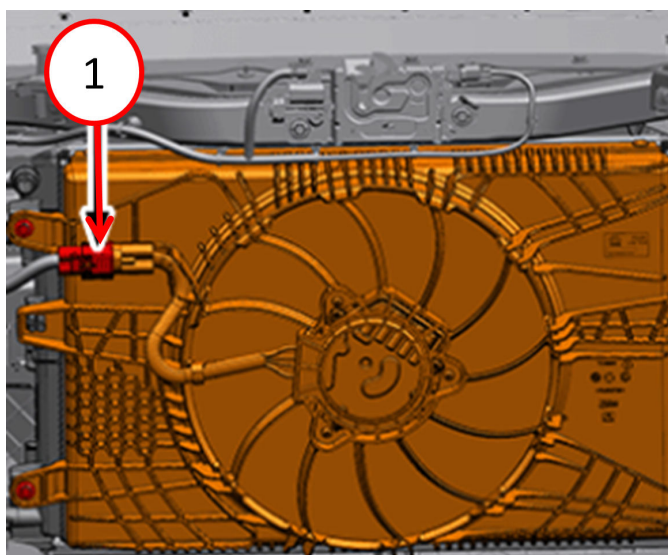
**Fig. 1**  
Cooling Fan Assembly

1 - Wire Harness To Disconnect/Connect

4. Disconnect the cooling fan wire harness connector [Fig. 1](#).

24. Install the #38 AGSM fuse [Fig. 3](#) and the PDC cover [Fig. 2](#).
25. Position the rear carpet in place.
26. Connect the cooling fan wire harness connector [Fig. 1](#).
27. Install the front storage bin. Refer to the detailed service procedures available in DealerCONNECT/ ServiceLibrary under: Service Info> 23 - Body / Exterior / Bin, Storage / Installation.
28. Clear any DTCs that may have been set in any modules due to reprogramming. The wiTECH application will automatically present all DTCs after the flash and allow them to be cleared.

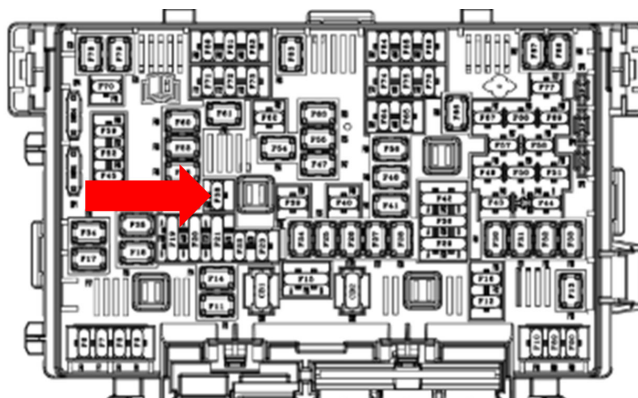
**Fig. 3**  
#38 AGSM Fuse Location

**Failure to remove the #38 AGSM fuse will result in damage to the shifter.**

6. Remove the PDC cover, locate and remove the #38 AGSM fuse [Fig. 3](#).
