<b>REFERENCE:</b>	<b>TSB:</b> 08-025-25 REV. C <b>GROUP:</b> 08 - Electrical	<b>Date:</b>	July 10, 2025	<b>REVISION:</b>	08-025-25 REV. B						
<b>VEHICLES AFFECTED:</b>	<p><b>2025 (LB) Dodge Charger</b> This bulletin applies to vehicles built on or before April 03, 2025 (MDH 0403XX) equipped with 400V G2500 FR/RR Elec Drive Motors (Sales Code ELD).</p>			<p><b>MARKET APPLICABILITY:</b></p>

<ul style="list-style-type: none"> <li>● P0AA1-00 - Hybrid/EV Battery Positive Contactor "A" Stuck Closed.</li> <li>● P0FF8-00 - Hybrid/EV Battery Precharge Contactor Circuit "B" Stuck Closed.</li> </ul> <p><b>Customers may also comment on one or more of the following:</b></p> <ul style="list-style-type: none"> <li>● Wrench icon is illuminated on the Instrument Panel Cluster (IPC).</li> <li>● Vehicle will not enter Drive Ready Mode.</li> </ul> <p><b>This bulletin also includes the following software enhancements:</b></p> <ul style="list-style-type: none"> <li>● Bootloader update to prevent battery disconnect unit damage.</li> <li>● Improvements in detecting pre-existing battery disconnect unit damage.</li> <li>● Charging related enhancements that may lead to DTC P0CA6 falsely setting.</li> </ul

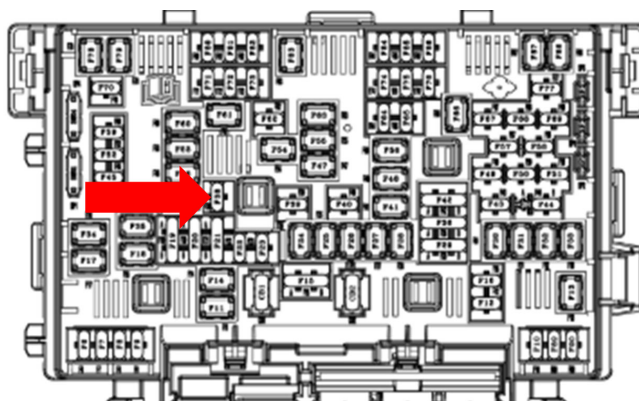
**Fig. 3**  
#38 AGSM Fuse Location

Failure to remove the #38 AGSM fuse will result in damage to the shifter.

- Remove the PDC cover, locate and remove the #38 AGSM fuse [Fig. 3](#).

24. Install the #38 AGSM fuse [Fig. 3](#) and the PDC cover [Fig. 2](#).
25. Position the rear carpet in place.
26. Connect the cooling fan wire harness connector [Fig. 1](#).
