**Technical Service Bulletin (TSB)**  
**RSU With Additional Sleep Cycles for HV Battery Integrity Check**  
**- Flash: Battery Pack Control Module (BPCM) Updates 11A2**

<b>REFERENCE:</b>	<b>TSB:</b> 08-071-25 REV. C <b>GROUP:</b> 08 - Electrical	<b>Date:</b>	July 10, 2025	<b>REVISION:</b>	08-071-25 REV. B						
<b>VEHICLES AFFECTED:</b>	<p><b>2024 (LB) Dodge Charger</b> This bulletin applies to vehicles equipped with 400V G2500 FR/RR Elec Drive Motors (Sales Code ELD).</p>			<p><b>MARKET APPLICABILITY:</b></p>

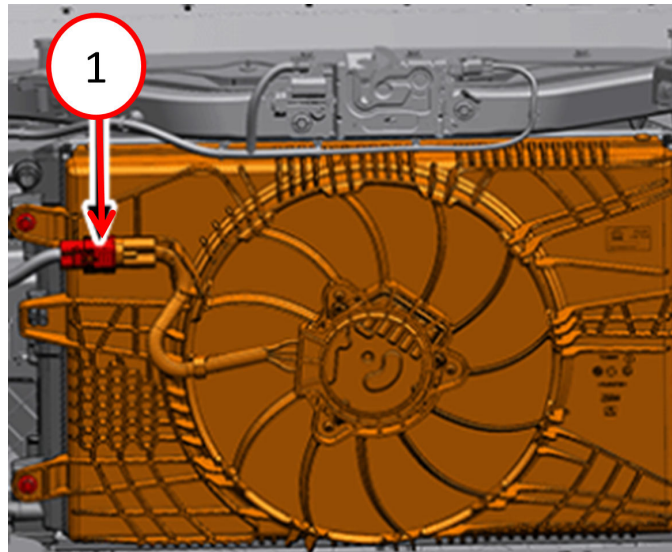
**Fig. 1**  
Cooling Fan Assembly

1 - Wire Harness To Disconnect/Connect

4. Disconnect the cooling fan wire harness connector [Fig. 1](#).

26. Connect the cooling fan wire harness connector [Fig. 1](#).

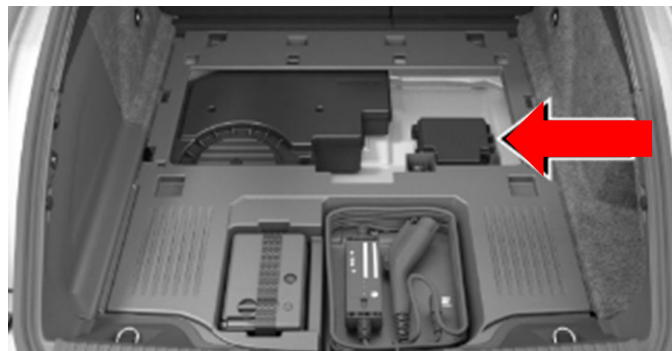
**Fig. 2**

Rear PDC Location

5. From the rear of the vehicle, pull back the carpet to access the rear Power Distribution Center (PDC) [Fig. 2](#).

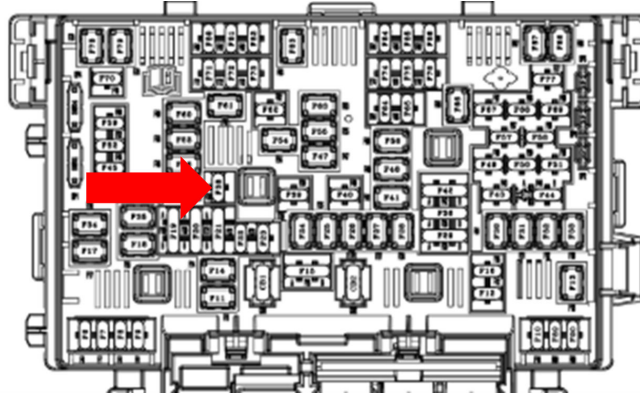
**Fig. 3**

**Failure to remove the #38 AGSM fuse will result in damage to the shifter.**

#38 AGSM Fuse Location

6. Remove the PDC cover, locate and remove the #38 AGSM fuse [Fig. 3](#).

24. Install the #38 AGSM fuse [Fig. 3](#) and the PDC cover [Fig. 2](#).
