<b>REFERENCE:</b>	<b>TSB:</b> 08-076-25 REV. C <b>GROUP:</b> 08 - Electrical	<b>Date:</b>	July 10, 2025	<b>REVISION:</b>	08-076-25 REV. B						
<b>VEHICLES AFFECTED:</b>	<p><b>2024 (KM) Jeep Wagoneer S</b> This bulletin applies to vehicles equipped with 400V G2500 FR/RR Elec Drive Motors (Sales Code ELD).</p>			<p><b>MARKET APPLICABILITY:</b></p>

<ul style="list-style-type: none"> <li>• P0FF8-00 - Hybrid/EV Battery Precharge Contactor Circuit "B" Stuck Closed.</li> </ul> <p><b>Customers may also comment on one or more of the following:</b></p> <ul style="list-style-type: none"> <li>• Wrench icon is illuminated on the Instrument Panel Cluster (IPC).</li> <li>• Vehicle will not enter Drive Ready Mode.</li> </ul> <p><b>This bulletin also includes the following software enhancement:</b></p> <ul style="list-style-type: none"> <li>• Bootloader update to prevent battery disconnect unit damage.</li> <li>• Improvements in detecting pre-existing battery disconnect unit damage.</li> <li>• Charging related enhancements that may lead to DTC P0CA6 falsely setting.</li> </ul>
<b>CAUSE:</b>	<b>BPCM software update</b>

This bulletin involves reprogramming the IDCM, BPCM, MCP A, MCP B and the EVCU

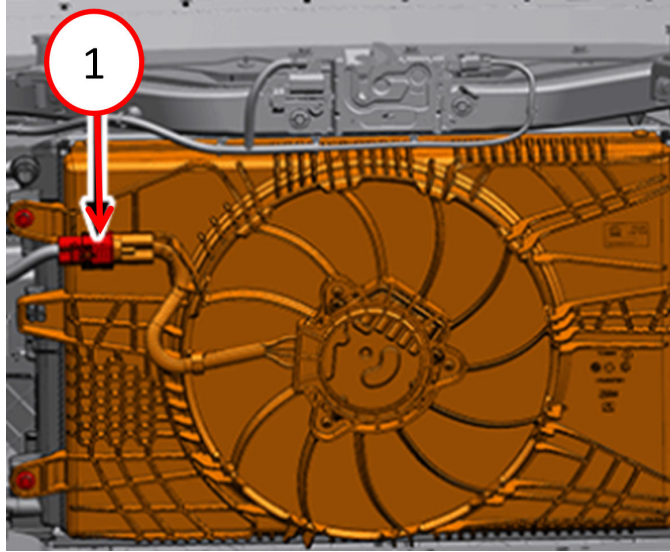
**Fig. 1**  
Cooling Fan Assembly

1 - Wire Harness To Disconnect/Connect

**NOTE: The cooling fan must be disconnected to prevent it from powering on, which may interrupt/ abort the flash process.**
4. Disconnect the cooling fan wire harness connector [Fig. 1](#).

21. Connect the cooling fan wire harness connector [Fig. 1](#).
