REFERENCE:	TSB: 08-133-25 REV. A GROUP: 08 - Electrical	Date:	July 10, 2025	REVISION:	08-133-25
VEHICLES AFFECTED:	2025 (LB) Dodge Charger This bulletin applies to vehicles built on or before April 03, 2025 (MDH 0405XX) equipped with 400V G2500 FR/RR Elec Drive Motors (Sales Code ELD).			MARKET APPLICABILITY: <input checked="" type="checkbox"/> NA <input checked="" type="checkbox"/> MEA <input checked="" type="checkbox"/> SA <input checked="" type="checkbox"/> IAP <input checked="" type="checkbox"/> EE <input checked="" type="checkbox"/> CH NOTE: **This bulletin applies to North and South America, Enlarged Europe, Middle East & Africa, India & Asia Pacific and China markets.**	
CUSTOMER SYMPTOM:	Customers may comment on one or more of the following: <ul style="list-style-type: none"> • 12 volt battery lamp on the Instrument Panel Cluster (IPC) illuminated due to depleted 12 volt battery. • Unable to charge at High Voltage Charging station at Level-1, Level-2 or DC Fast Charge.

CAUSE:	IDCM software update

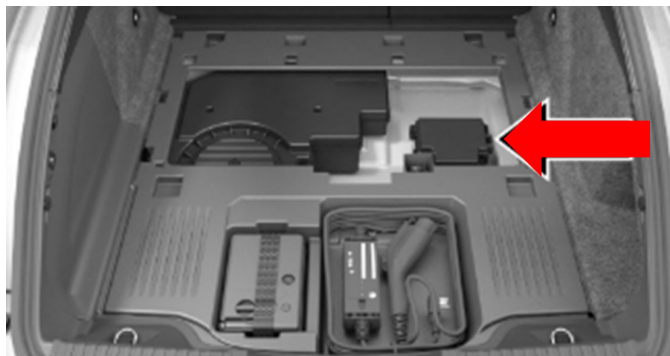
**Fig. 2**

Rear PDC Location

5. From the rear of the vehicle, pull back the carpet to access the rear Power Distribution Center (PDC) [Fig. 2](#).

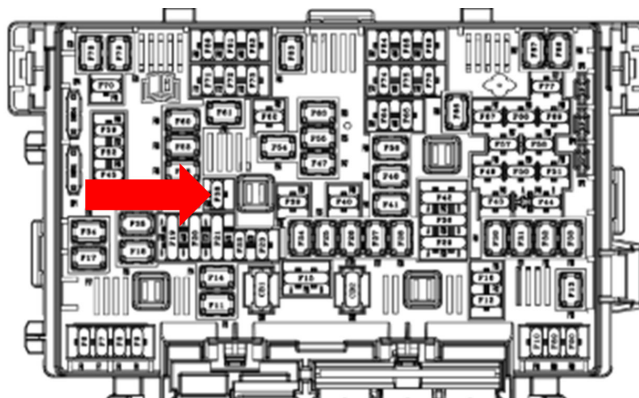
**Fig. 3**

Failure to remove the #38 AGSM fuse will result in damage to the shifter.

#38 AGSM Fuse Location

6. Remove the PDC cover, locate and remove the #38 AGSM fuse [Fig. 3](#).
