Technical Service Bulletin (TSB)
Loose Charge Air Cooler Case Crimp

REFERENCE:	TSB: 09-017-25 GROUP: 09 - Engine	Date:	July 11, 2025	REVISION:	—
VEHICLES AFFECTED:	2025 (DT) RAM 1500 Pickup This bulletin applies to vehicles built on and after March 21, 2025 (MDH 0321XX) and on or before April 15, 2025 (MDH 0415XX) equipped with 3.0L I6 Hurricane SO Twin Turbo ESS (Sales Code EFH).			MARKET APPLICABILITY: <input checked="" type="checkbox"/> NA <input type="checkbox"/> MEA <input type="checkbox"/> EE <input type="checkbox"/> IAP <input type="checkbox"/> SA <input type="checkbox"/> CH NOTE: This bulletin applies to the North America market.	
CUSTOMER SYMPTOM:	<p>Customers must experience a Malfunction Indicator Lamp (MIL) illumination and the vehicle must exhibit/set one or more of the following Diagnostic Trouble Codes (DTCs):</p> <ul style="list-style-type: none"> ● P219C-00 - Cylinder 1 Air-fuel Ratio Imbalance. ● P219D-00 - Cylinder 2 Air-fuel Ratio Imbalance. ● P219F-00 - Cylinder 4 Air-fuel Ratio Imbalance. ● P21A0-00 - Cylinder 5 Air-fuel Ratio Imbalance. ● P21A1-00 - Cylinder 6 Air-fuel Ratio Imbalance. <p>Customers may experience one or more of the following:</p> <ul style="

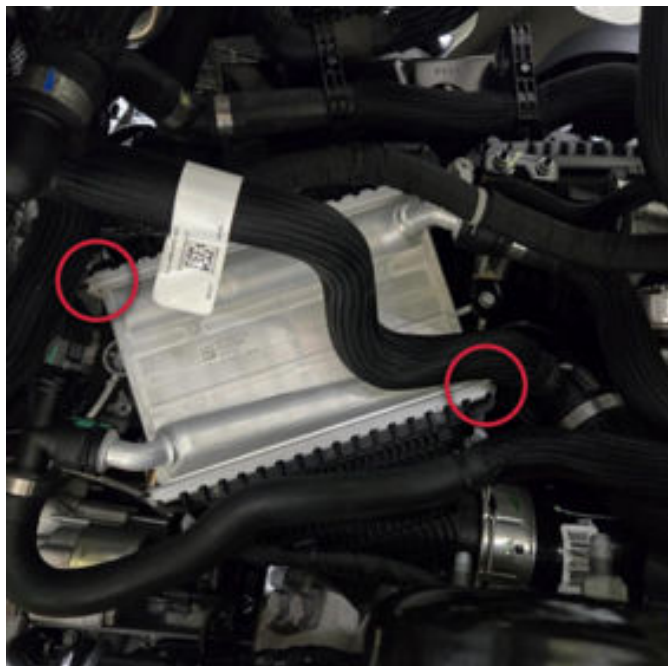
Fig. 1
Charge Air Cooler Case Crimp

1. Raise the vehicle on the hoist. Refer to the detailed service procedures available in DealerCONNECT/ Service Library under: 04 - Vehicle Quick Reference / Hoisting / Standard Procedure.
2. Inspect the crimp on the Charge Air Cooler Case [Fig. 1](#).

- 1 - Charge Air Cooler Case Location
- 2 - Charge Air Cooler Case Crimp Correct Condition
- 3 - Charge Air Cooler Case Crimp Incorrect Condition

-
3. Is the Charge Air Cooler Case crimp visible and/or able to be felt by hand?
 - YES>>> Proceed to [Step 4](#).
 - NO>>> This RSU does not apply. Use Inspect LOP (07-58-10-93) to close this active RSU.

6. Replace the Charge Air Cooler. Refer to the detailed service procedures available in DealerCONNECT/ Service Library under: 09 - Engine, 3.0L GMET6 / Turbocharger System / Cooler and Hoses, Charge Air / Removal and Installation.
