STAR ONLINE PUBLICATION

Case Number: S2508000048

Release Date: July 2025

Symptom/Vehicle Issue: Charging Status Lights Inoperable (No Illumination) at Charge Port, Vehicle Still Does Charge

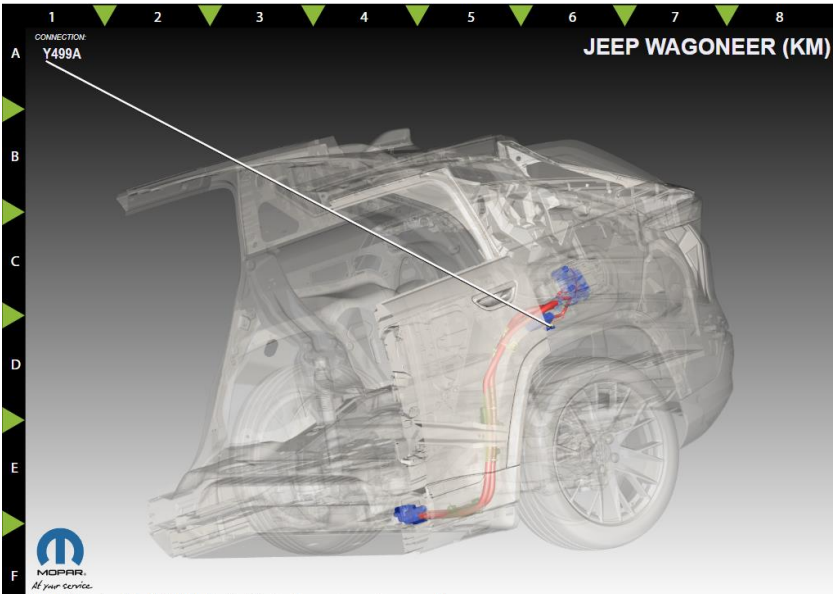
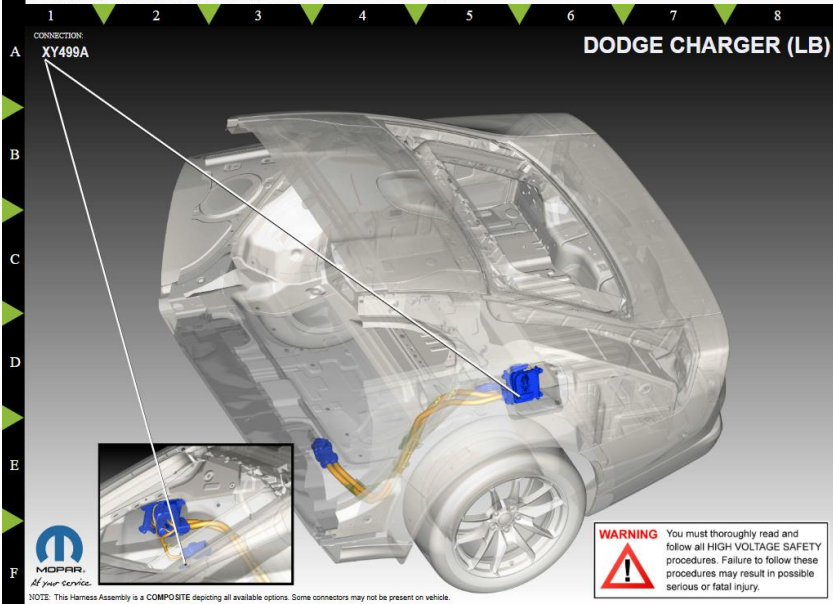
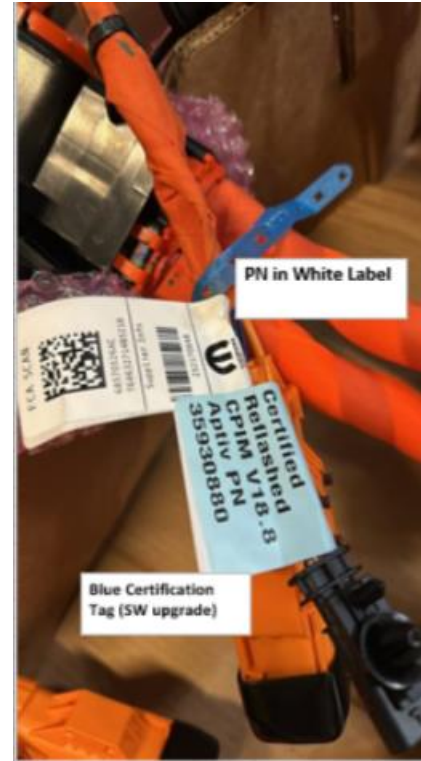
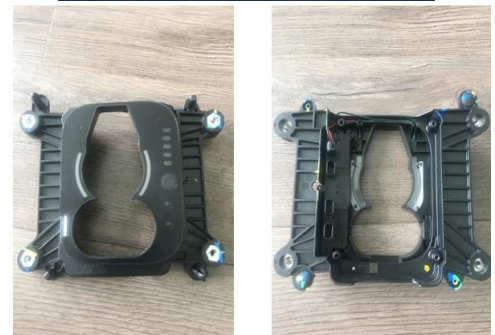
4. Follow High Voltage (HV) safety procedures when accessing Charge Port wiring branches.
5. Inspect for the label/labels see pg 2, attached to the Charge Port's wiring branch that contains the XY499A connection.

6. If the part number (PN) on white label is 68570526AD, the charge port has the upgraded Software (SW) version, continue with normal diagnostics.
7. If PN on the white label is 68570526AC AND the additional blue certification tag is present; the charge port has the upgraded SW version. See reference picture for blue certification tag, continue with normal diagnostics.

8. If part number on the white label is 68570526AC AND the additional blue certification tag is NOT present, the charge port interface is suspect of having an older SW version creating the condition described.

9. The Charge Status Indicator/Interface component PN 68752336AA with the software updates can be ordered as replacement Pg 2 - 7. There is no need to replace the Charge Port as an Assembly to fix this condition.
