Rapid Update 766

Grecale Multiple Software Updates

AGSM - BSM - CVPAM - ICS - IPC - RFHM - BCM - ECM - TCM

DATE: July 15, 2025

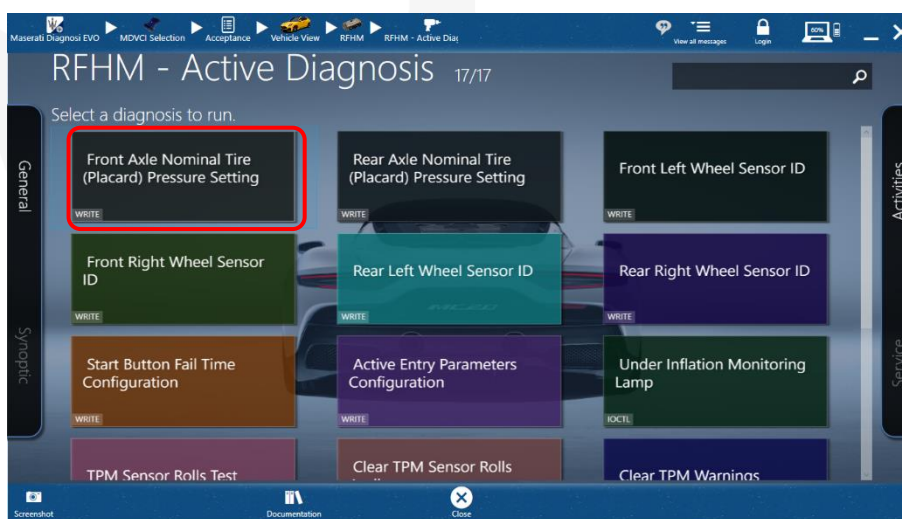
This update is essential to prevent the occurrence of a false TPMS (Tire Pressure Monitoring System) warning indication. In specific situations, the front tire pressures might erroneously appear in yellow on the cluster display, even when the actual tire pressures meet or exceed the specified values. This problem stems from an incorrect internal calculation related to the hexadecimal conversion between psi and bar. It's crucial to note that this update does not alter the tire pressure values as stated in the owner manuals and technical documentation.

IMPORTANT for 19" tires only:

- Select **RFHM – Active diagnosis – Front Axle Nominal Tire (Placard) Pressure Setting:**

- Insert **31** in the text box and click on **Execute** to set the new value.

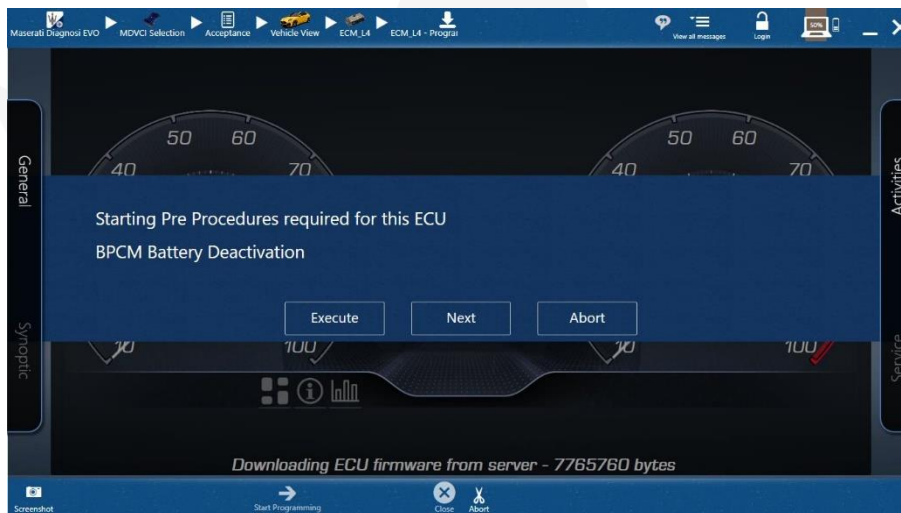
This update is essential to rectify a potential loss of CAN communication between the ECM and other ECUs (AGSM, DTMC, BSM, etc.) when the ECU temperature is high. This new software corrects this behavior avoiding multiple warning lights. No loss of torque or recovery strategy is activated for this concern. The new software also fixes a potential MIL attributed to P-codes P106A and P1066 related to the MultiAir solenoid valve. **This Software update requires the TCM to be updated as well.**

- From ECU View, select the **ECM – ECU programming**.
- Press **“Execute”** starting pre-procedures:

- After ECU programming, perform **BCM – Procedures – PROXI Alignment**.
- Clear DTCs.
