**Diagnostic Sheet**

# Noise from the front suspensions while maneuvering

DATE: July 16, 2025

**MODELS:** Ghibli (M157), Levante (M161) and Quattroporte (M156) (All MY)

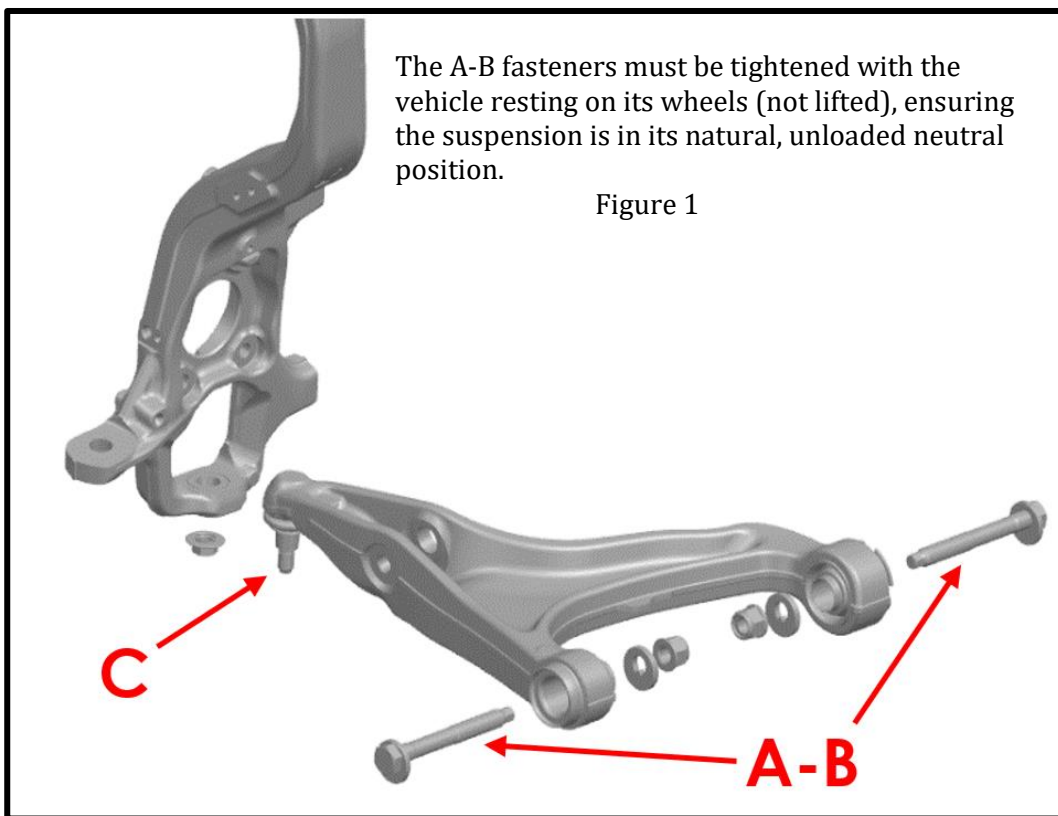
Retighten the bushings and ball joint fasteners (A and B in Fig. 1) of the arm to the chassis and the ball joint head (C in Fig. 1).

- Arm-to-chassis bushings:
  - Levante (M161): 265 Nm
  - Ghibli/Quattroporte (M15x): 140 Nm
- Ball joint to upright: 70 Nm (All Models)
  - Loosen each fastener by 360° and retighten to the correct torque using a torque wrench.

- If resolved: No further action required.
- If noise persists: Replace the noisy lower front suspension arm and retest.

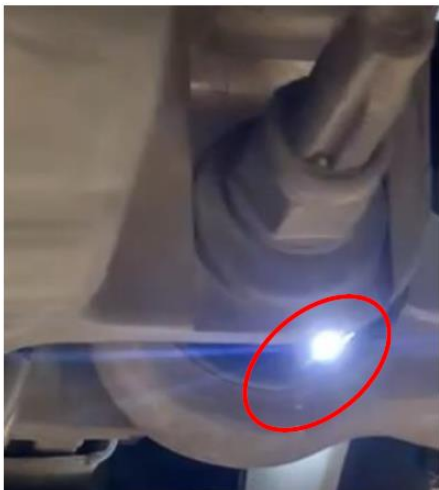
Picture taken when installed in the vehicle. When moving the rubber mount back and forth, light can be seen coming out through the cracked hole.

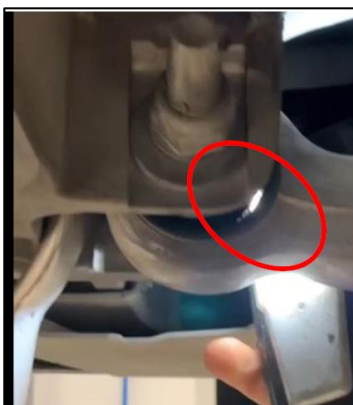
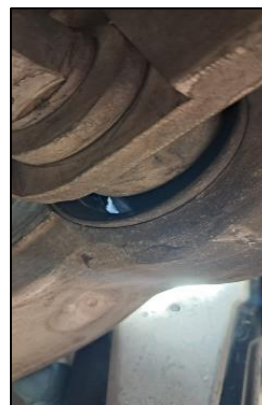
Examples of extensive rubber breakage around the external circumference.

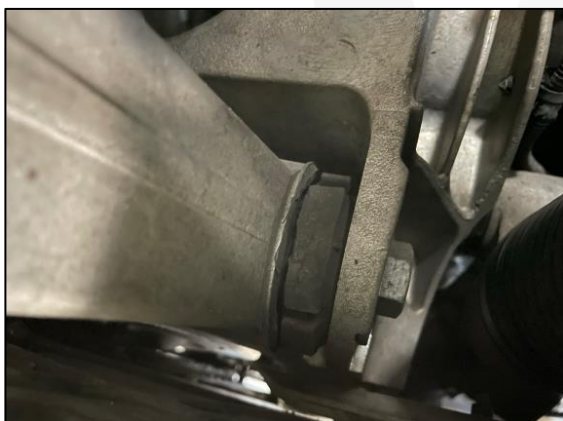
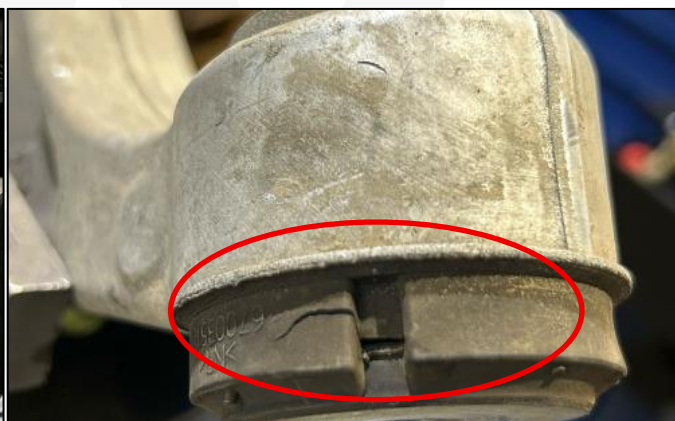
The images below are examples of bushings requiring replacement
