Technical Information

FROM: Maserati TSO

MC20 - Carbon Ceramic Brakes - Track Use

DATE: July 15, 2025

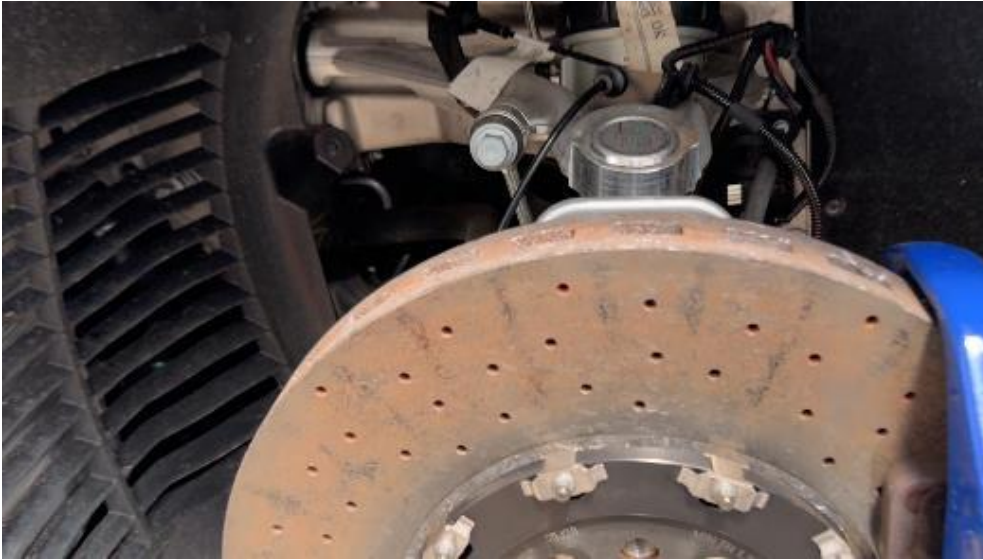
- Oxidation of Discs and Pads – Identified by a copper-colored layer on the disc braking surface and/or pad surface

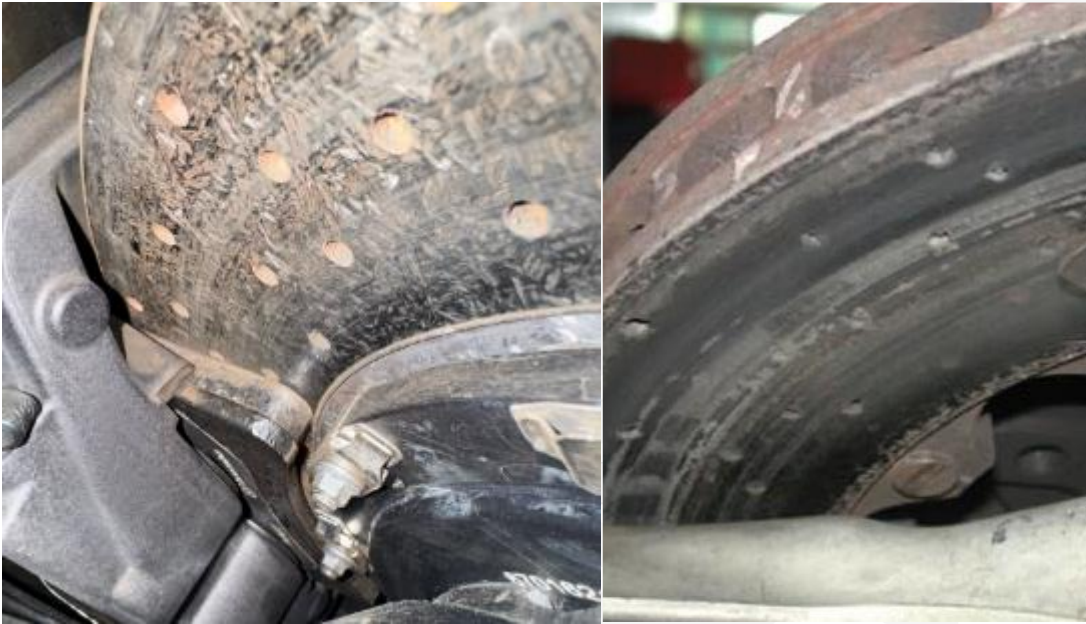
- Disc Hole Occlusion or Surface Damage – Plugged ventilation holes or visibly damaged friction surface

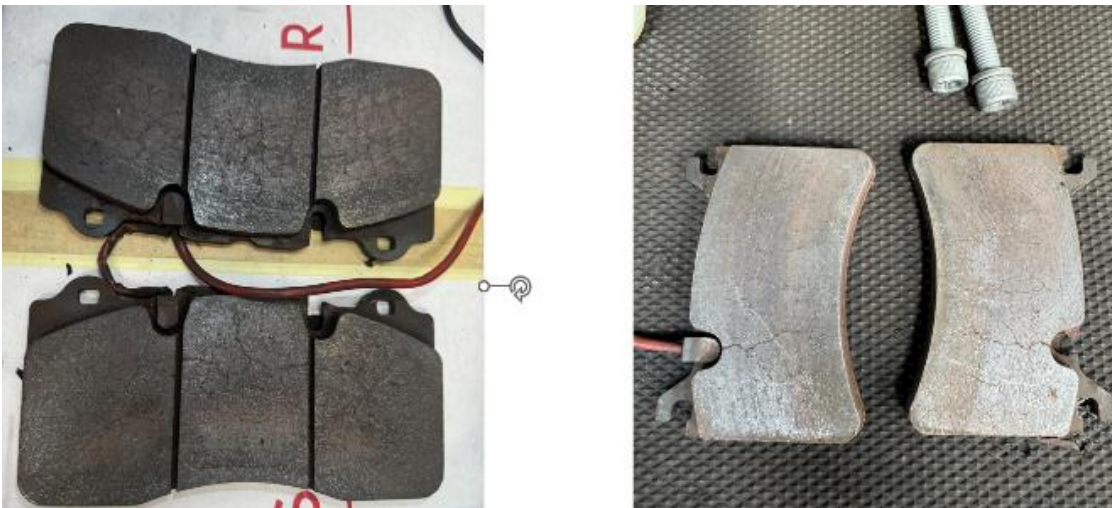
- Cracks in the Brake Pad Friction Material

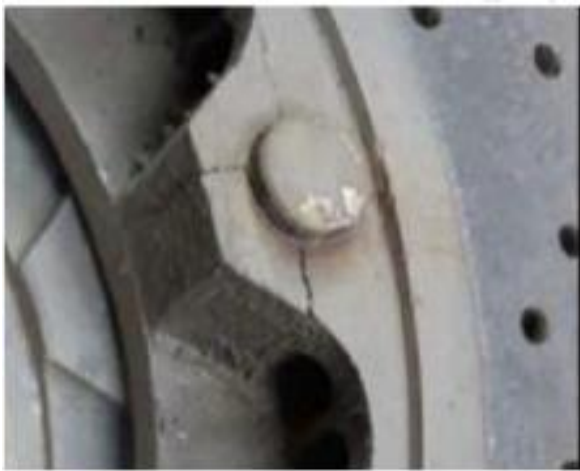
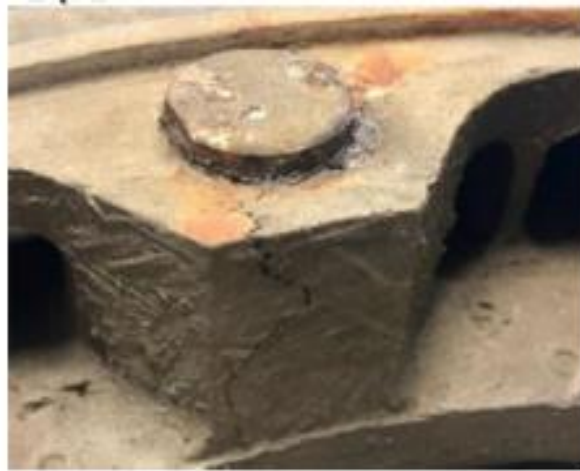
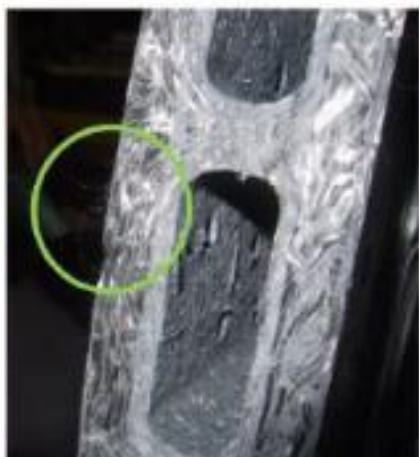
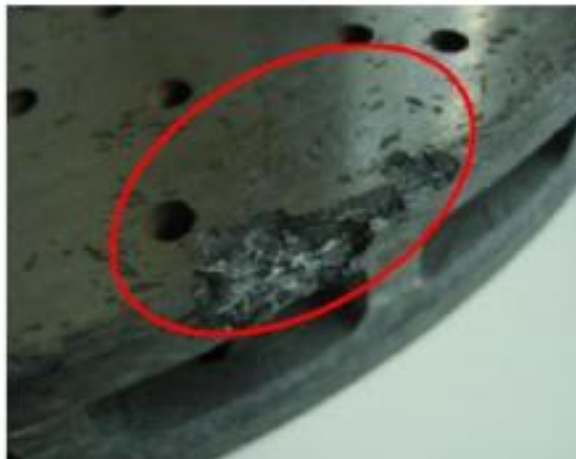
• Cracks or Damage to Other Areas of the Brake Disc

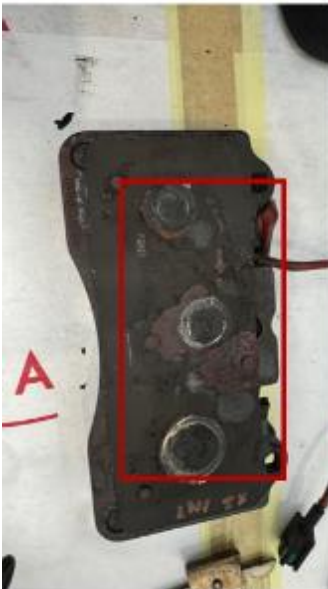
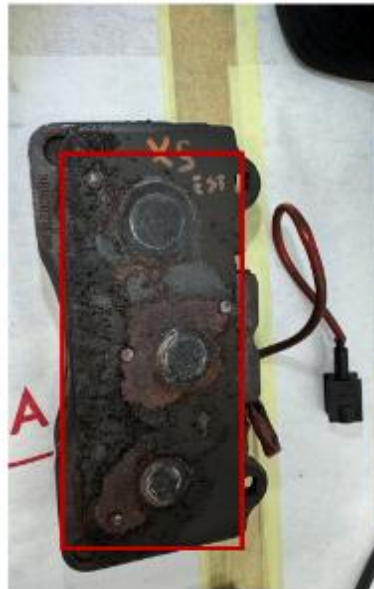
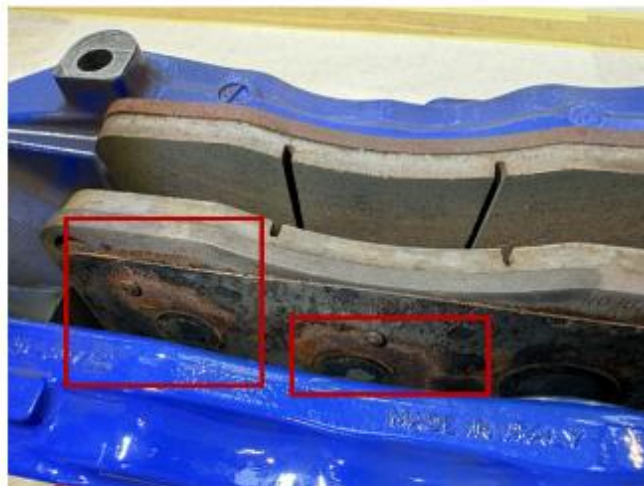
• Signs of Burning or Overheating on Pad Metal Components

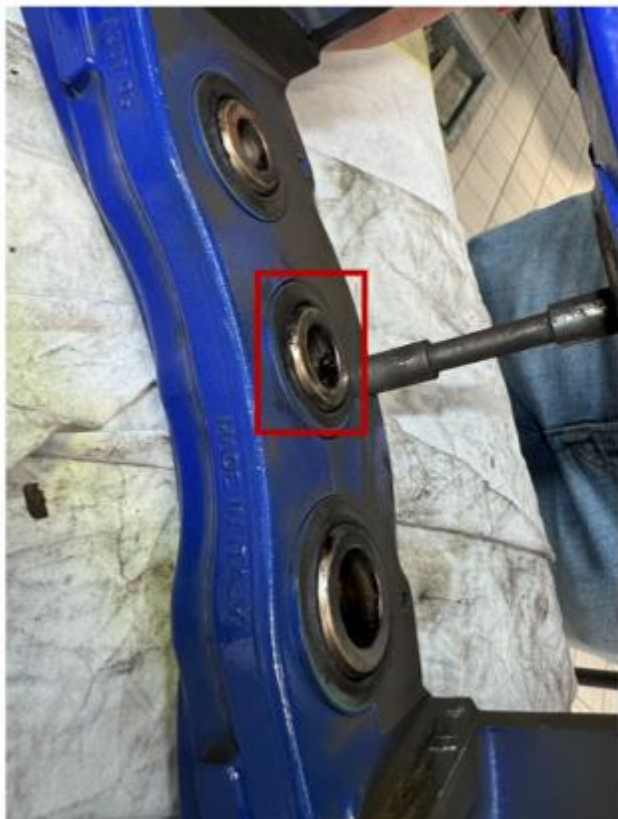
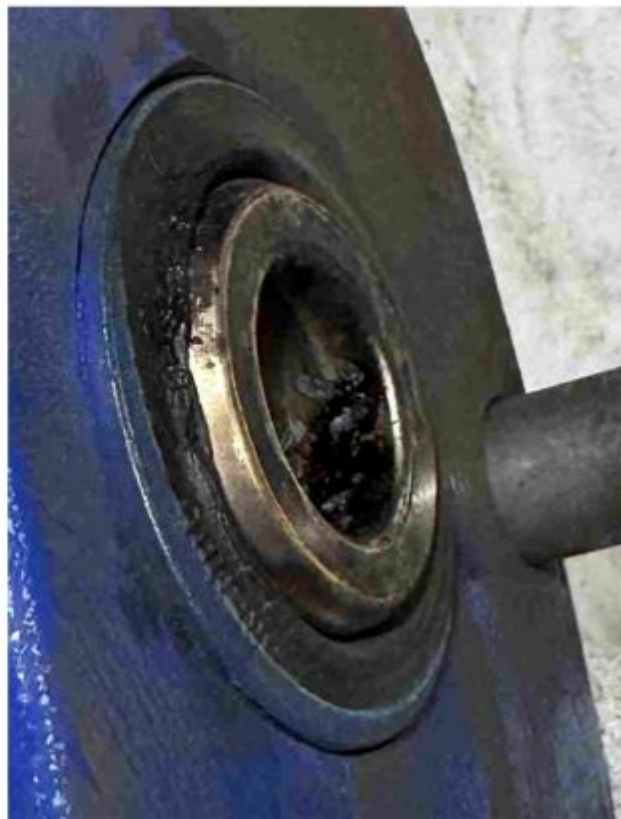
• Burn/Overheat Marks on Caliper Linings

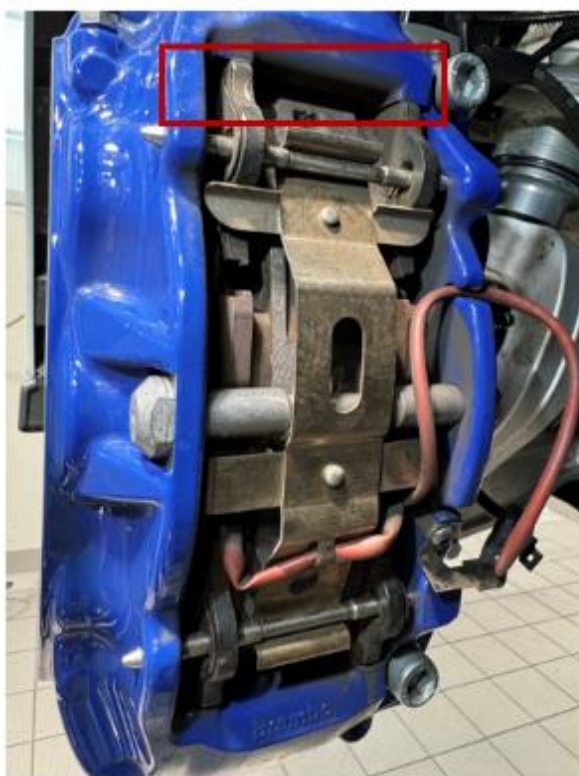
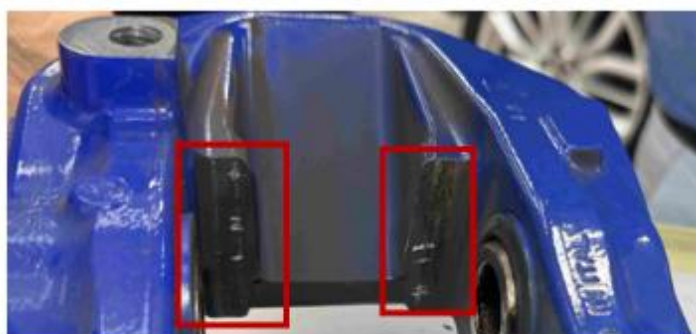
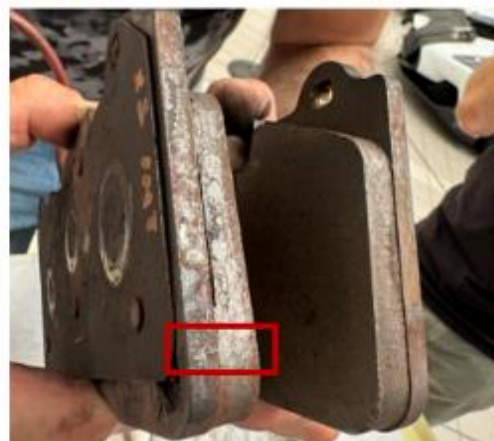
• Markings Indicating Forward Rotation Direction – Found on the edge of the pad seat within the calipers and on the pad edges themselves
