Diagnostic Sheet

Engine Oil Leak Diagnostic Path

DATE: JULY 11, 2025

MODELS AFFECTED: All models and all engines.

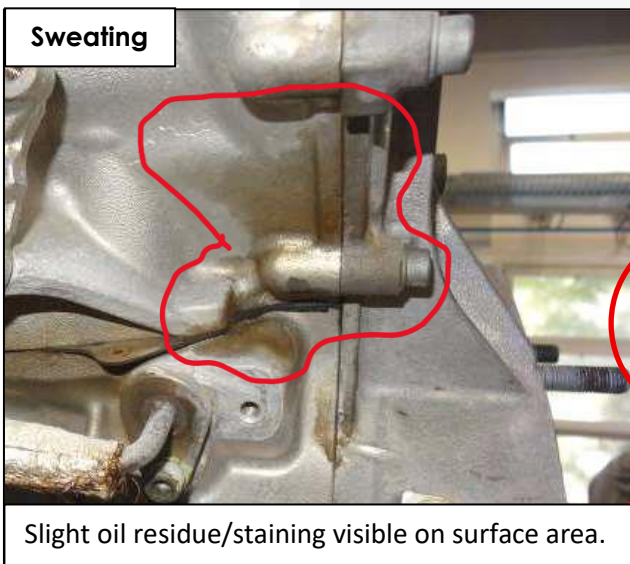
Sample photo: 3.0 V6 430HP engine

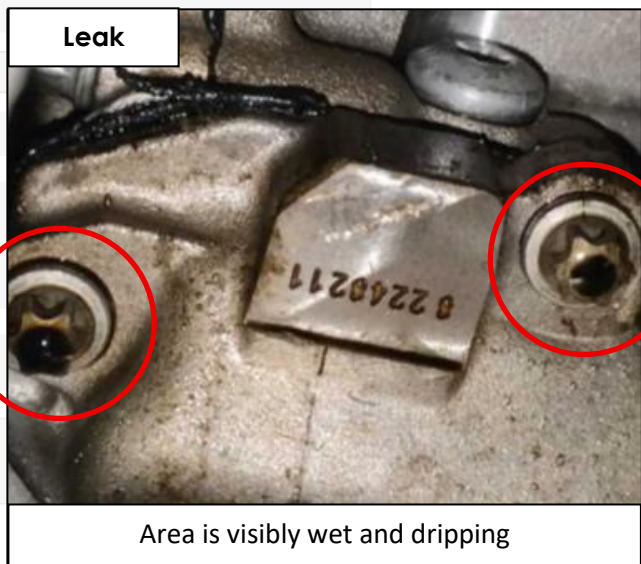
Sample photo: 2.0 L4 MHEV engine

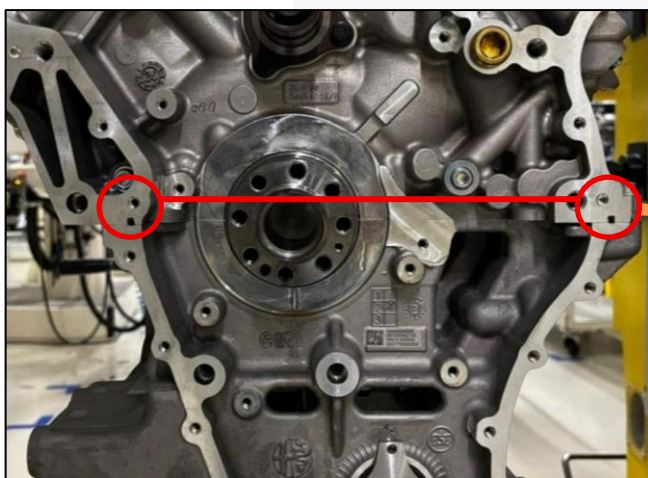
FIGURE 1

- **For V6 Trofeo (Grecale/GranTurismo) and Nettuno (MC20) engines:**
 - If the timing cover is leaking, photograph the joint area (Figure 1).
 - Check for gasket protrusion into crankcase (Figure 2).
 - If protrusion exists, carefully trim it using a suitable tool without damaging aluminum surfaces.
