All M17x - Oil Leak from Rear Main Seal Area

Topic number	LI01.40-P-079518
Version	1
Function group	01.40 - Crankcase, timing case cover, end cover
Date	7/16/25
Validity	All M17x Variants
Reason for change

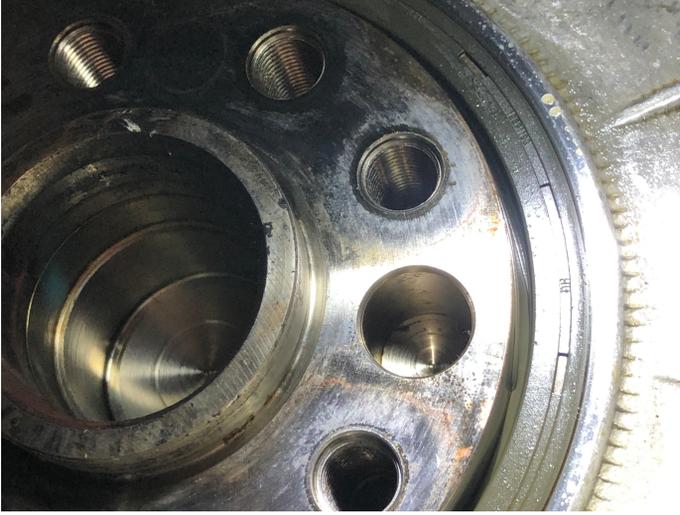
Attachments	
File	Description
Rolled Seal.jpg

Oil leaking from rear main seal and/or rear main seal plate.

Inspect the rear main seal very carefully. Make sure the seal is not sucked in, rolled, or cut (see pictures in attachments).

If the leak is emanating from the seal: replace both air/oil separators. Then clean the bellhousing area completely and test with trace powder again to see if the leak remains. If it doesn't, release the car.

If the leak remains pull the rear main seal plate, clean the block mating surface completely and replace the rear main seal plate and rear main seal. When the new seal is installed make sure the sealant path is followed exactly as it is shown per the drawing in the attachments.
