July 08, 2025

Version 1

DTC P0134 and P0135 – Air/Fuel Sensor 1 Heater Malfunction (MIL ON)

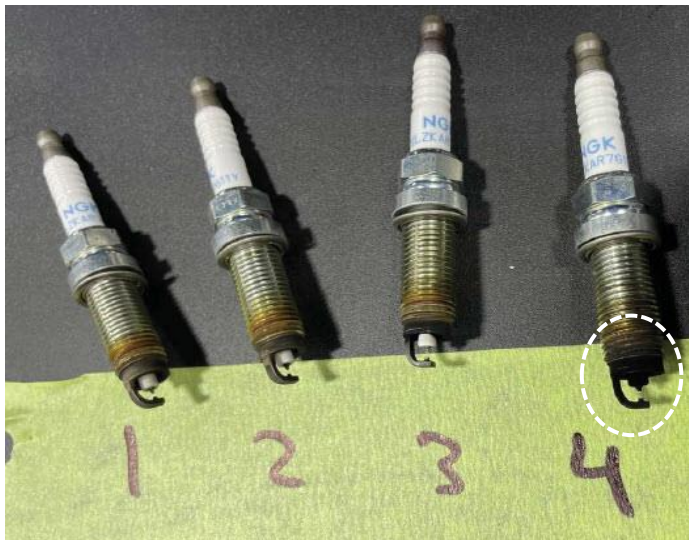
A fuel injector leak causes a rich air/fuel (A/F) mixture that fouls the spark plug(s) and causes the PCM to misread the A/F sensor heater resistance. Other DTCs may also include: P0700, P0300, P219C, P219D, P219E, P219F, P0172.

NOTE: Refer to #4 spark plug in the image below as an example of a rich A/F mixture.

YES: Replace the affected spark plug(s) and all fuel injectors.

1. Follow the service manual to replace the affected spark plug(s) and all fuel injectors.
2. After reconnecting the vehicle's battery, perform the Steering Angle Neutral Position Learning Procedure.
