REFERENCE:	TSB: 08-205-25 REV. A GROUP: 08 - Electrical	Date:	July 16, 2025	REVISION:	08-205-25
VEHICLES AFFECTED:	2025 (LB) Dodge Charger This bulletin applies to vehicles built on or before April 03, 2025 (MDH 0403XX) equipped with 400V G2500 FR/RR Elec Drive Motors (Sales Code ELD).			MARKET APPLICABILITY: <input checked="" type="checkbox"/> NA <input checked="" type="checkbox"/> MEA <input checked="" type="checkbox"/> SA <input checked="" type="checkbox"/> IAP <input checked="" type="checkbox"/> EE <input checked="" type="checkbox"/> CH NOTE: This bulletin applies to North and South America, Enlarged Europe, Middle East & Africa, India & Asia Pacific and China markets.	
CUSTOMER SYMPTOM:	Customers may experience a Malfunction Indicator Lamp (MIL) illumination and the vehicle may exhibit/set one or more of the following Diagnostic Trouble Codes (DTCs): <ul style="list-style-type: none"> • C10FA-00 - Wheel Hub disconnect Actuator Performance Left. • C10FB-00 - Wheel Hub disconnect Actuator Performance Right. Customers may also comment on the following: <ul style="list-style-type: none"> • Wrench icon is illuminated on the Instrument Panel Cluster (IPC).

CAUSE:	EVCU software upda

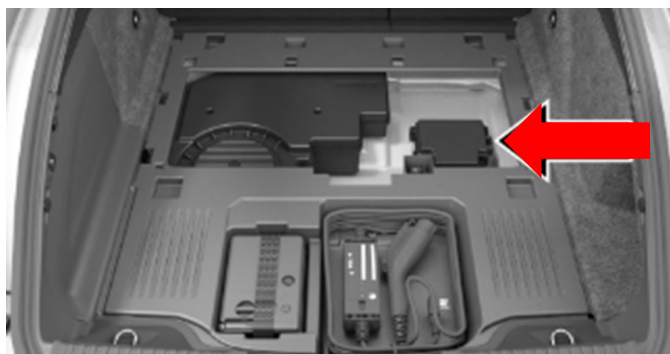
Fig. 1
Rear PDC Location

1. ****Is the vehicle on the RSU VIN list?**
 - YES >>> Proceed to [Step 2](#).
 - NO >>> Proceed to [Step 3](#).
2. Does the EVCU have the latest software already installed?
 - YES >>> This bulletin has been completed, use inspect LOP **** (18-19-85-91)**** to close the active RSU.
 - NO >>> Proceed to [Step 3](#).******
3. From the rear of the vehicle, pull back the carpet to access the rear Power Distribution Center (PDC) [Fig. 1](#).

14. Install the #38 AGSM fuse [Fig. 2](#) and the PDC cover [Fig. 1](#).
