| <b>REFERENCE:</b> | <b>TSB:</b> 08-205-25 REV. B<br><b>GROUP:</b> 08 - Electrical | <b>Date:</b> | July 18, 2025 | <b>REVISION:</b> | 08-205-25 REV. A |
| <b>VEHICLES AFFECTED:</b> | <b>2025 (LB) Dodge Charger</b><br>This bulletin applies to vehicles built on or before <b>**April 25, 2025 (MDH 0425XX)**</b> equipped with 400V G2500 FR/RR Elec Drive Motors (Sales Code ELD). | | | <b>MARKET APPLICABILITY:</b><br><input checked="" type="checkbox"/> NA <input checked="" type="checkbox"/> MEA<br><input checked="" type="checkbox"/> SA <input checked="" type="checkbox"/> IAP<br><input checked="" type="checkbox"/> EE <input checked="" type="checkbox"/> CH<br><br><b>NOTE:</b> This bulletin applies to North and South America, Enlarged Europe, Middle East & Africa, India & Asia Pacific and China markets. | |
| <b>CAUSE:</b> | EVCU software update | | | | |

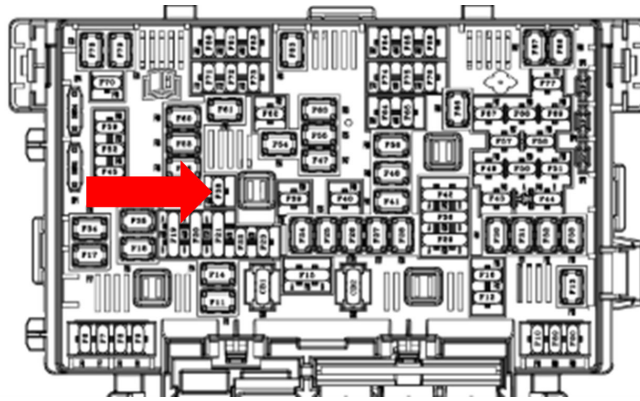
**Fig. 2**

#38 AGSM Fuse Location

4. Remove the PDC cover, locate and remove the #38 AGSM fuse [Fig. 2](#).

- NOTE: If the Wheel End Disconnect Position Learn routine is not successful, roll the vehicle slightly forward so that the wheel end disconnect actuators can align on the spline before attempting to perform the routine again.**
14. Install the #38 AGSM fuse [Fig. 2](#) and the PDC cover [Fig. 1](#).
15. Position the rear carpet in place.
16. Clear any DTCs that may have been set in any modules due to reprogramming. The wiTECH application will automatically present all DTCs after the flash and allow them to be cleared.
