Technical Service Bulletin (TSB)
Telematics Box Module (TBM) Over The Air Software Update From 5.39.1 To 5.65

REFERENCE:	TSB: 08-219-25 GROUP: 08 - Electrical	Date:	July 18, 2025	REVISION:	—
VEHICLES AFFECTED:	<p>2022 - 2023 (DT) RAM 1500 Pickup 2022 - 2023 (DJ) RAM 2500 Pickup 2022 - 2023 (D2) RAM 3500 Pickup 2022 - 2023 (DD) RAM 3500 Cab Chassis 2022 - 2023 (DF) RAM 3500 10K LB Chassis This bulletin applies to vehicles built on and after May 12, 2023 (MDH 0512XX) and on and before August 31, 2023 (MDH 0831XX) equipped with a Global Telematics Box Module (Sales Code RDG).</p>			<p>MARKET APPLICABILITY:</p> <p><input checked="" type="checkbox"/> NA <input type="checkbox"/> MEA <input type="checkbox"/> SA <input type="checkbox"/> IAP <input type="checkbox"/> EE <input type="checkbox"/> CH</p> <p>NOTE: This bulletin applies to the North America market.</p>	
CUSTOMER SYMPTOM:	<p>Customers may experience the following:</p> <ul style="list-style-type: none"> 'SOS unavailable' popup message. 				
CAUSE:	TBM software

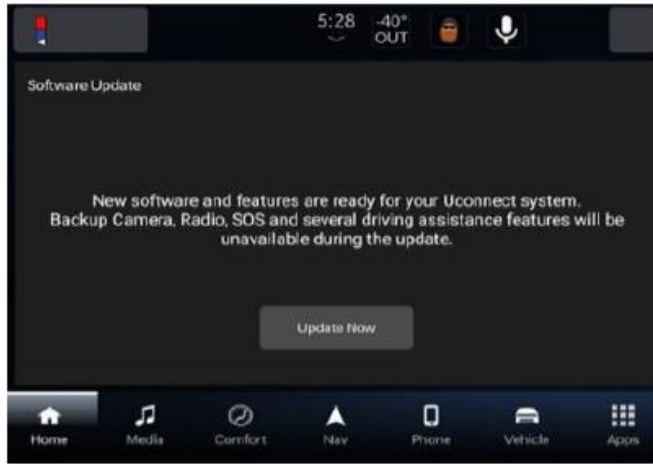
Fig. 1

Vehicles sold in the U.S. and Canada can now receive software updates “over-the-air”. Updates to software will occur in a phased roll-out. The software is updated through a builtin cellular modem in the vehicle. Customers will see a notification on their radio screen when new software is available for their TBM [Fig. 1](#).

Software Acceptance Screen

1. The vehicle needs to be in 'Park'. The ignition needs to be in the off position.
2. If the customer selects "Update Now" [Fig. 1](#) they can shut off the vehicle and leave. The update will be completed automatically.

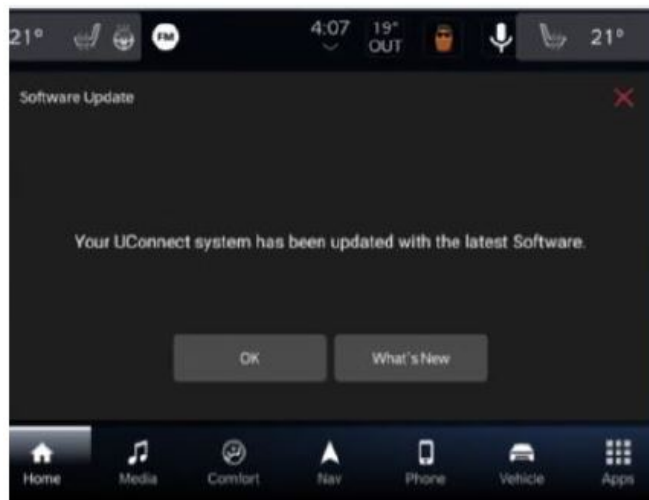
Fig. 2

3. Upon completion of update, the radio will display a confirmation message [Fig. 2](#).

Software Update Confirmation Screen
