GROUP	MODEL
BOD	2025MY NIRO HEV, PHEV, EV (SG2 P/HEV, EV)
NUMBER	DATE
339	July 2025

TECHNICAL SERVICE BULLETIN

SUBJECT: SERVICE ACTION: RIGHT FRONT BODY PANEL SEALANT APPLICATION (SA607)

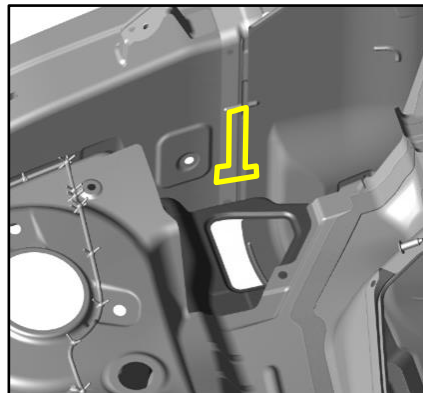
Body Seam (yellow area)

This bulletin provides instructions to add body sealant to the right front panel seam area, which may not have sufficient sealant applied during assembly on certain 2025MY Niro HEV, PHEV, and EV (SG2 P/HEV, EV) vehicles produced between October 31, 2024, and December 13, 2024. The affected vehicles may exhibit water leak intrusion into the cabin (front passenger seat) floor area. Follow the procedure outlined in this publication to add additional sealant to the right front body panel seam. Before starting, verify that the vehicle is included in the list of affected VINs.

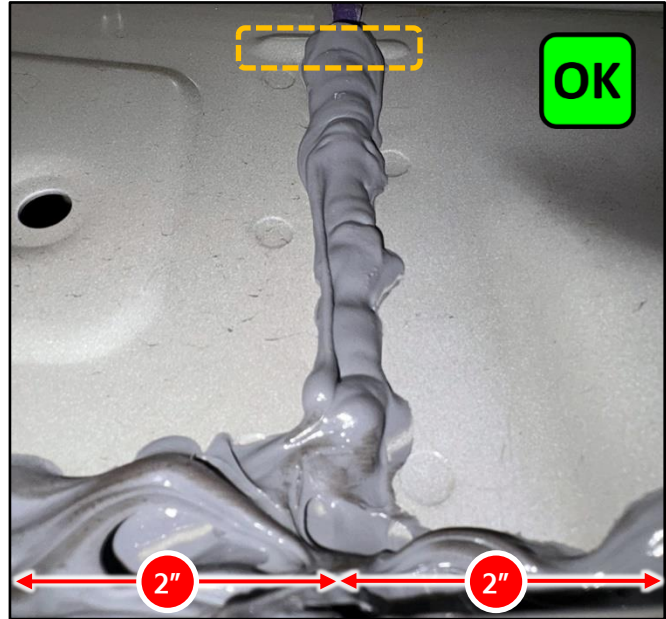
Refer to the **OK** image shown. Sealant was applied covering over the existing seam.

6. Apply a generous amount of body sealant over the existing vertical body seam area (top to bottom) starting from the alignment embossed body line.
7. Apply another generous amount of sealant across the horizontal lower bottom seam (left to right) at least 2" inches from the center to both left and right side as shown.

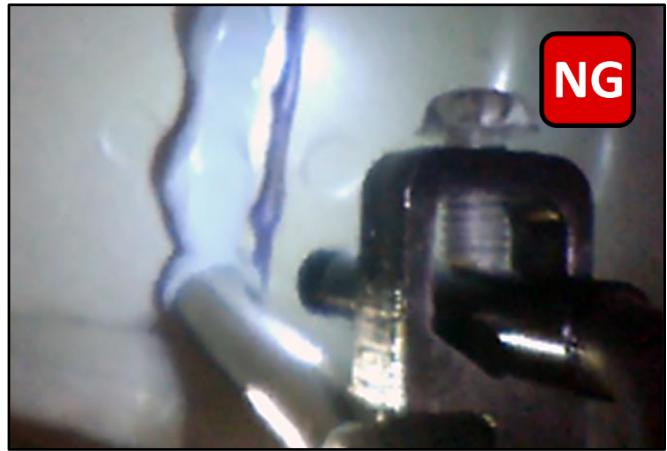
Refer to the **NG** image shown. Body sealant was not applied over the body seam area.
