SIB 34 10 25

2025-07-14

CHECK CONTROL MESSAGE (CCM): BRAKE SYSTEM. DRIVE AT MODERATE SPEED

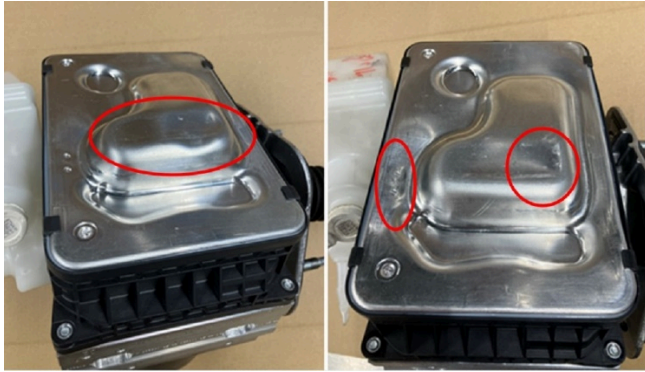
Do not install any part which shows visual damage as shown in the photo or has been dropped from any height.
