This Service Information Bulletin (Revision 03) replaces SI B51 12 23 **dated April 2025**.

Front Lower Active Air Flap Assembly Vehicle-Specific Customer Satisfaction Initiative 4/50

Front Lower Active Air Flap Assembly Vehicle-Specific Customer Satisfaction Initiative

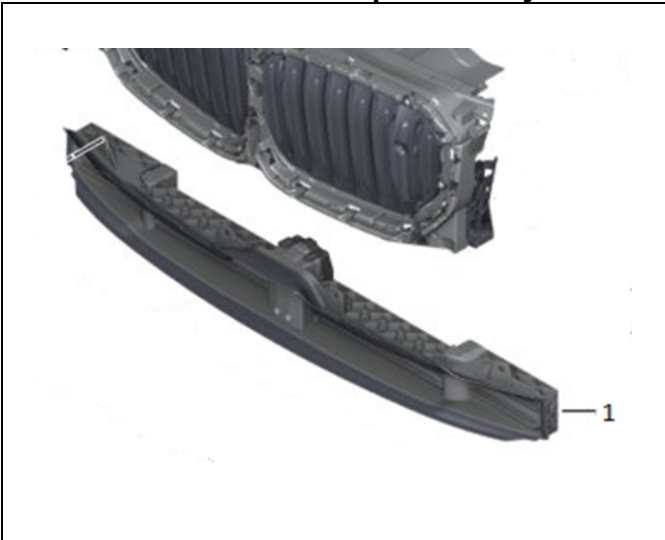
After carrying out the vehicle test, one or more of the stored faults indicate that the operation of the front bottom active air flap is obstructed or blocked.

Thoroughly inspect the front bottom air flap, when applicable, remove any contamination that is found caught in and between the bottom air flaps (aka “blinds”) and/or the housing.

For the eligible listed vehicles that qualify, and for the issue described in the photo (**item # 1 shown**):

1. When contamination is found to be the reason why the bottom active air flap (blind) operation is restricted, provide a photo document what is found in the WarrantyAPP, and carefully remove the contamination (Removal of the front bumper cover is not necessary).
2. Delete the fault memory, carry out the test module's functional check again to verify the repair, or
