SIB 61 10 25

WASHER FLUID RESERVOIR FILLER CHANNEL LEAK

E-Series	Model Description	Production Date	Affected Option Code
U10	X2 Sports Activity Coupe	As of November 2023	All
U11	X1 Sports Activity Vehicle	As of July 2023	All

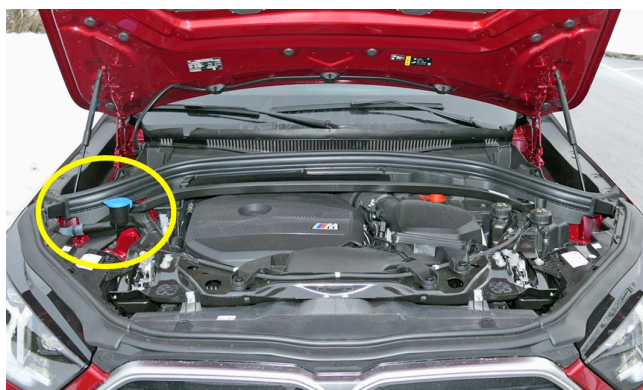
The washer fluid reservoir (filler neck circled) may be leaking, and drains out through the wheel well liner. When the vehicle is parked, a puddle of washer fluid may be present under the right front corner.

The washer reservoir filler channel may not have been installed correctly at the factory.

Before replacing the washer fluid reservoir, check for proper installation of the filler channel.

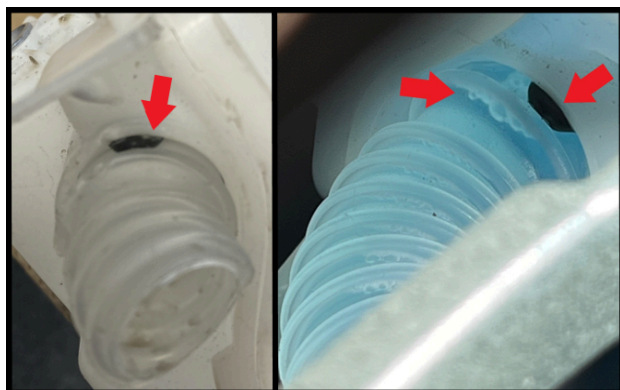
1. Examine the filler channel and washer reservoir connection point.

2. If one of the sealing O-ring's are extruding, replace the filler channel following repair instruction **61 71 081 | REP-REP-P-6171081-U11 - V.3**
