SIB 66 03 25

PARKING ASSISTANCE LIMITED CHECK CONTROL MESSAGE DUE TO PDC SENSORS

This Service Information Bulletin (Revision 3) replaces SI B66 03 25 **dated May 22nd, 2025.**

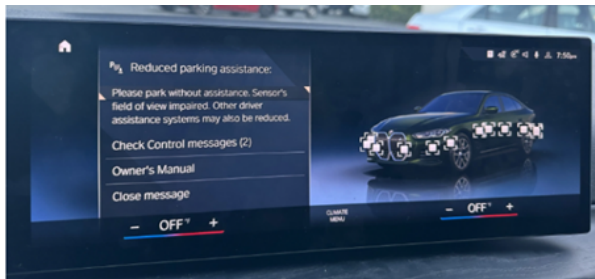
The parking assistance limited check control message can be related to environmental influence, component degradation, or unfavorable UCAP module software

Example photo of check control message Displayed for reduced parking assistance.

If the root cause is not determined to be related to environmental influence (specific locations, roads, etc..), or component failures then reprogramming of UCAP module with require I-level.

Program the vehicle to the I-level **25-07-530** or more recent using ISTA 4.54.3x (**estimated release end of July 2025**, pending verification) or **higher**

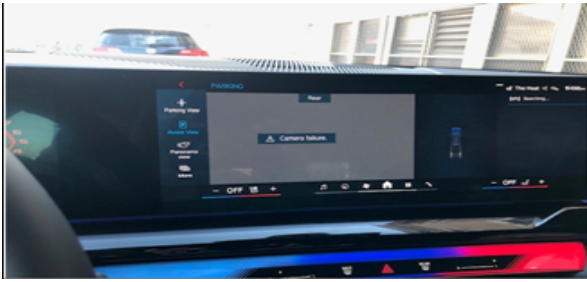
Example photo of camera failure message.
