SIB 84 03 25

Interference Noises During Calls

E-Series	Model Description	Affected Option Code
G09	BMW XM Sports Activity Vehicle	Without SA 5AX – Highway Assistant

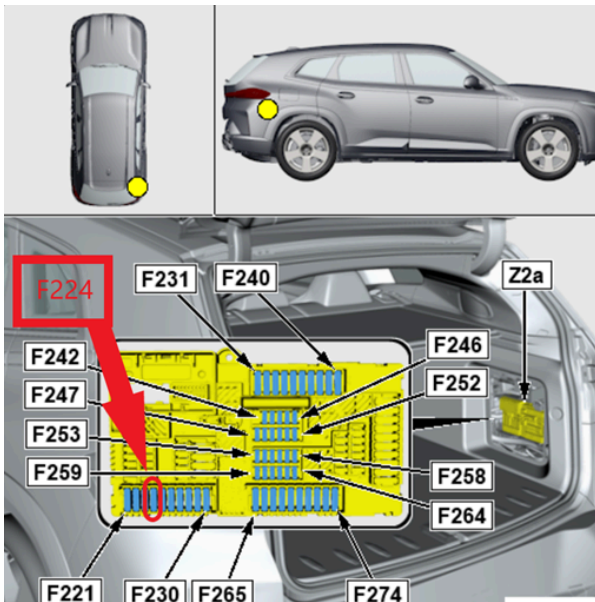
2. Next, remove fuse F224 (20A; circled/arrow) for the VDP module in the Rear Power Distribution Box (Z2a).
