SIM 51 16 16

CAVITY PROTECTION WAX LEAKING OUT OF HOOD

This Service Information Bulletin (Revision 5) replaces SI M51 16 16 dated July 2025.

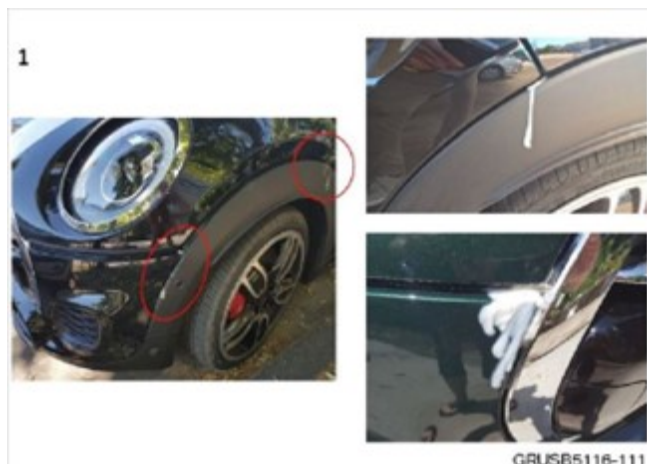
Cavity protection applied to the underside of the hood is leaking out onto the wheel arch trim and grille.

Improper application of cavity protection wax during vehicle production.

Remove the current protection and reapply it more accurately.
