SIM 61 07 25

## WASHER FLUID RESERVOIR FILLER CHANNEL LEAK

| E-Series | Model Description | Production Date |
|---|---|---|
| U25 | MINI Countryman S ALL4, SE ALL4 (Battery Electric Vehicle), JCW Countryman ALL4 | From SoP |

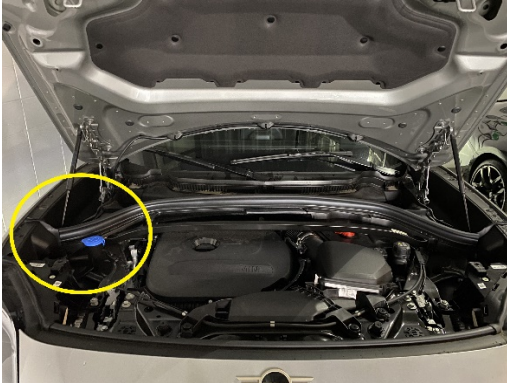
The washer fluid reservoir (filler neck circled) may be leaking, and drains out through the wheel well liner. When the vehicle is parked, a puddle of washer fluid may be present under the right front corner.

The washer reservoir filler channel may not have been installed correctly at the factory.

Before exchanging the washer fluid reservoir, check the installation of the filler channel O-ring between the reservoir and filler channel connection.

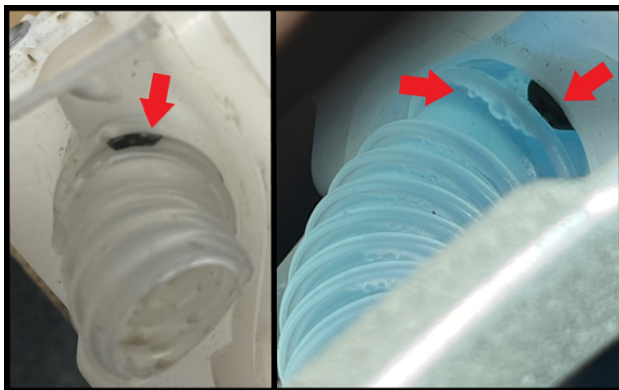
1. Examine the filler channel and washer reservoir connection point.

2. If any sealing O-rings are extruding, replace the filler channel following repair instruction 61 71 081 | REP-REP-P-6171081-U25 - V.1.
